H T Bettle & Co

Hustler 30

Type of vessel: Hustler 30 Fin Keel GRP Masthead sloop

Survey was conducted for [REDACTED] for the purpose of insurance
and valuation by Henry Bettle AMSCMS AMRINA AMIMarEST BEng, Marine
Surveyor.

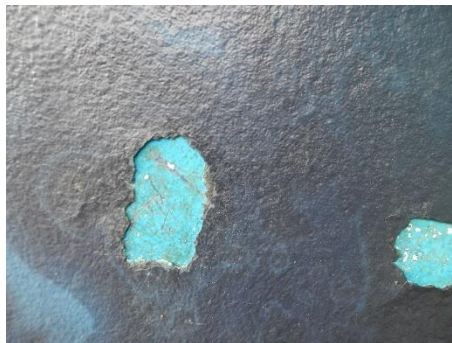
The underwater area of the hull was found to be coated with a blue antifoul. This was found to be in an end of season condition. The antifoul is flaking in a number of places. The vessel would benefit from the layers of antifoul being sanded back before a fresh coat is applied for the next season. The hull was tapped over at random in its entirety with a small rubber hammer, and there were no signs of any voids or delamination detected.

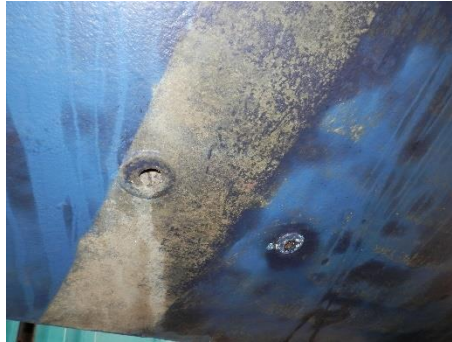
Skin Fittings: All skin fittings below the waterline were found to be in a good condition externally, with no signs of galvanic corrosion on the fittings.

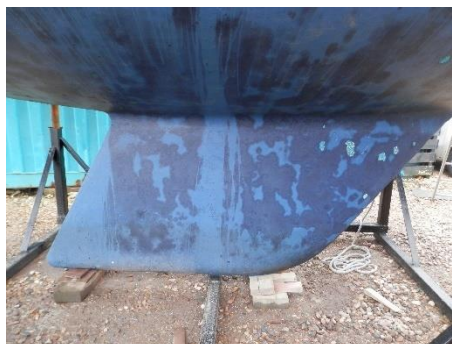
Keel: The encapsulated keel was found to be in a good condition overall, with no evidence of expansion of the iron, due to moisture ingress, noted. There are no signs of heavy grounding on the base of the keel noted.

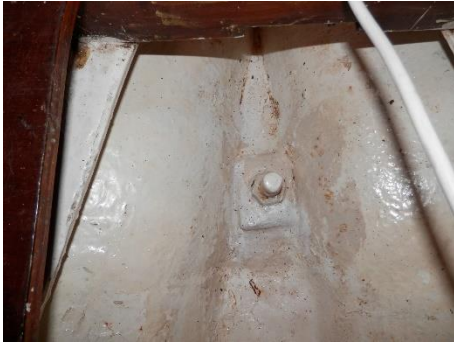
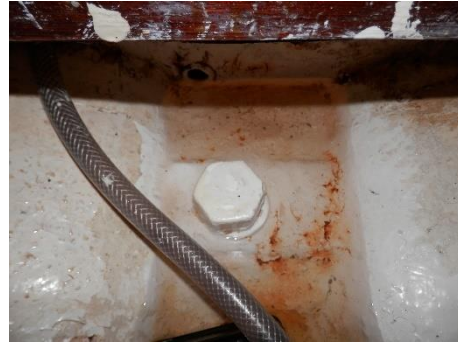
Keel bolts: All keel bolts were found to be in a good condition, with no signs of movement, or "weeping" noted.

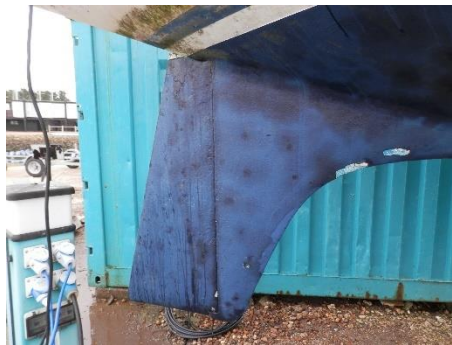
Moisture readings: Moisture readings of the rudder were taken at random over its entirety and found to range from 20 to 30. These readings are high, but common for this design of rudder and its age. No signs of blistering on the rudder, due to osmosis, was noted.

There is a small amount of lateral movement in the lower skeg mounting. This is a minor issue at this time. I recommend that the lateral play is monitored yearly for an increase. If the play becomes excessive, the lower mounting may need to be replaced.

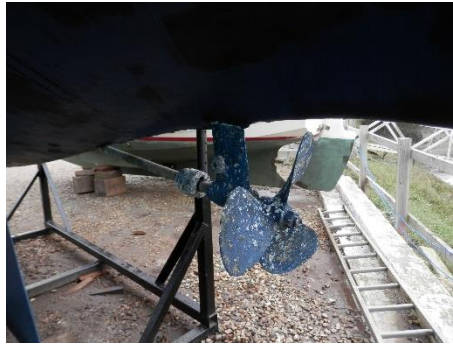
Propeller: The vessel is fitted with a 3-bladed bronze propeller, attached to a conventional shaft running through a cutlass bearing and "P" bracket. The propeller was found to be in a good condition, with no evidence of pitting or damage due to fouling noted. The propeller would benefit from having the multiple layers of antifoul removed.

The shaft and "P" bracket were both found to be in a good condition.

The cutlass bearing was found to be badly worn. The cutlass bearing should be replaced before the vessel is launched for the next season.

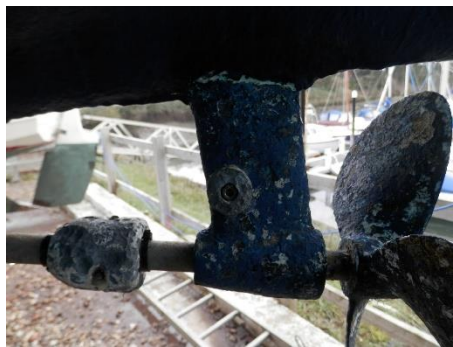
Anodes: There is a shaft anode, and a small "P" bracket circular anode, fitted to [REDACTED]. Both anodes are depleted, showing that they have been effective this season. Both anodes should be replaced for the next season.

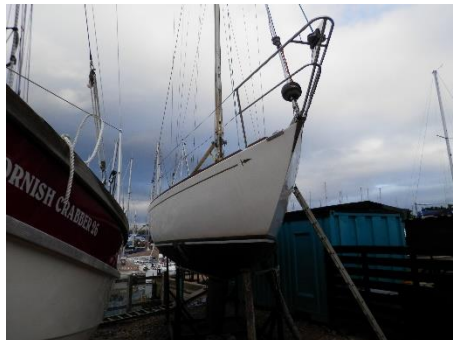
The white topsides, with gold strake stripe, are in a good condition overall. Taptests of the hull in 10 random locations, spanning the whole of the topsides, found that this was in a good condition, with no signs of delamination or weaknesses forming. The strake stripes were found to be in a good condition.

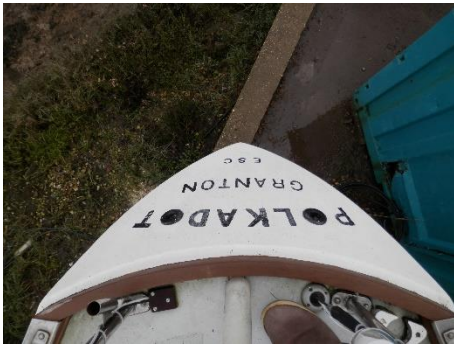
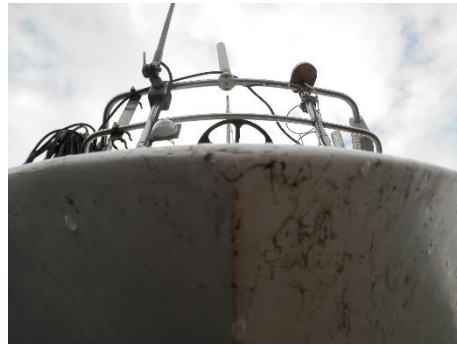
Transom: The transom is in a good condition overall. There is a small area of gelcoat damage on the lowest point of the transom. This is not a concern at this time.

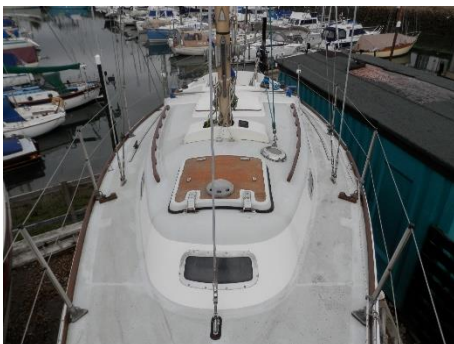
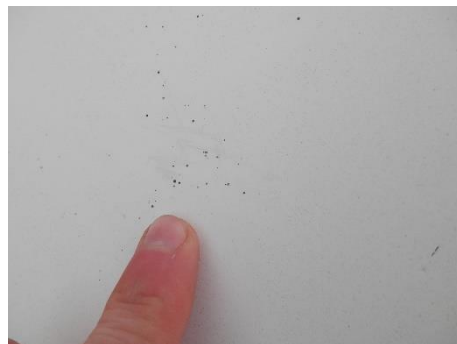
The deck and coachroof of the vessel still have their original light grey and white gelcoat. This is in a good condition overall. There are minor areas of pinhead blistering on the deck or coachroof. This is a cosmetic issue only. There are no areas of major cosmetic damage on the deck and superstructure of [REDACTED]

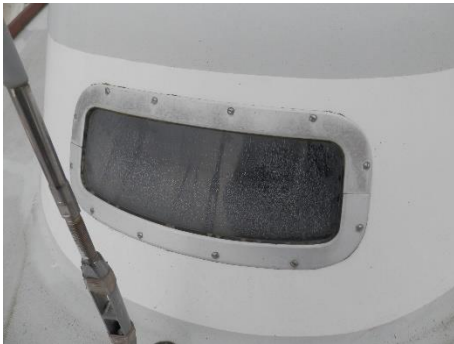
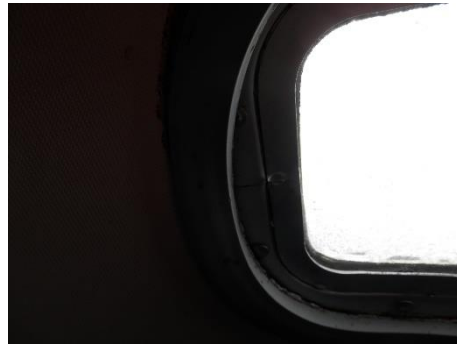
The fore-berth window was found to be dripping slowly during the survey. The window was also found to be crazed. I recommend that the fore-berth window is replaced and resealed.

- The fore-berth window should be replaced and re-sealed.

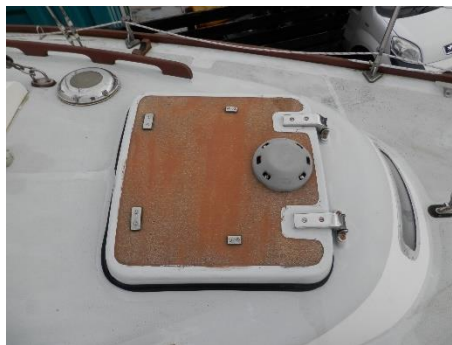
Hatches: The main V-berth hatch shows no signs of leaking or damage of the frame and was found to be in a good condition overall.

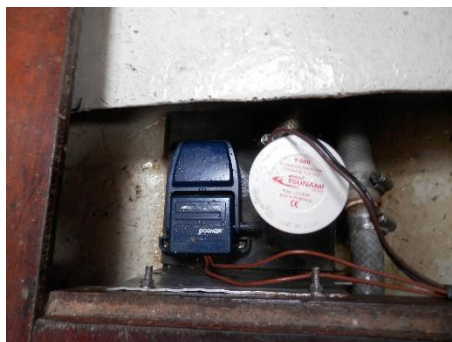
Condition of bilges: Access to the bilge is made by lifting the saloon sole boards and through the engine compartment. All portable boards were lifted for inspection. The bilges were found to be clean and dry in the most part, with a small amount of fresh water under the saloon sole boards. No signs of stress cracks or damage was noted. One Tsunami automatic bilge pump is fitted below the saloon. This was found to be working correctly. A manual bilge pump is fitted below the saloon floor. This was working correctly when tested. Two manual bilge pumps are fitted at the rear of the cockpit. Both bilge pumps were found to be working correctly during the survey. A replacement bilge pump, and a bilge pump servicing kit, was also found onboard.

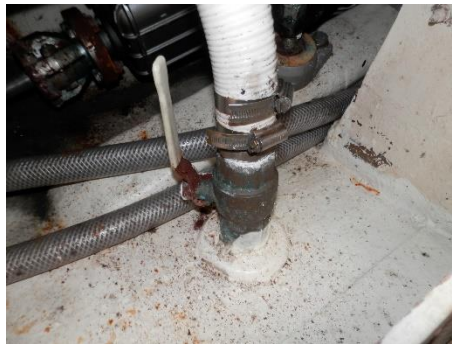
The engine inlet seacock should have two jubilee clips connecting it to its corresponding pipe.

Both cockpit drain seacocks were found to be stiff. Both seacocks should be serviced for the next season.

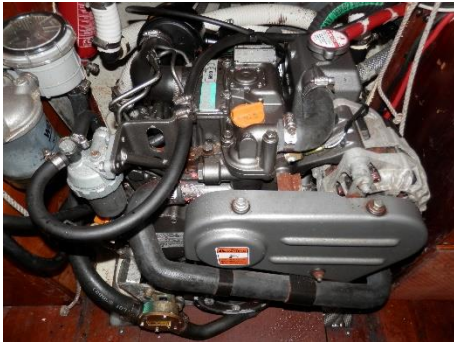
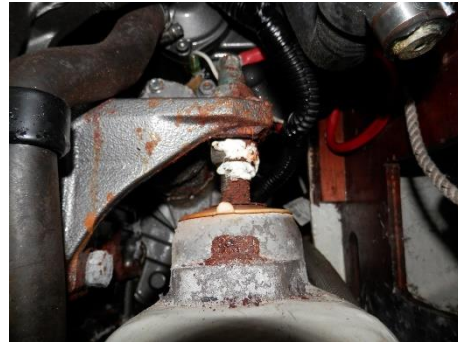
The engine was not started during the inspection. The engine and gearbox oils were found to be at the correct levels and clean. Externally, the engine is in a good condition, with little signs of corrosion or damaged paintwork. The piping and filters on the engine are in a good condition.

The engine mountings were found to be in a fair condition, with a layer of surface corrosion noted over all mountings. Although this is not a structural issue at this time, I recommend that all mountings are cleaned, rust treated and protected. This will prevent further corrosion of the mountings.

- Clean, rust treat, and protect the engine mountings.

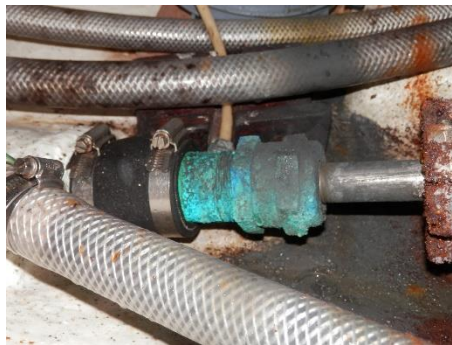
The grease packed stern gland was found to be in a good condition, with no signs of damage noted.

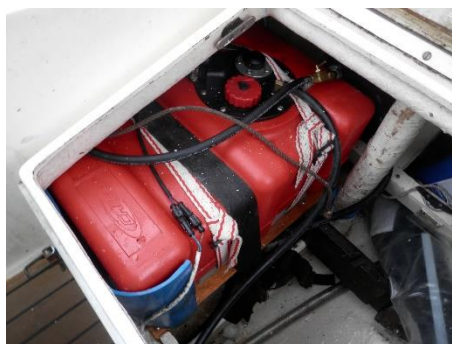
There is a 33L plastic fuel tank fitted at the aft of the cockpit. The tank is held in place by straps.

The fuel tank was found to be in a good condition, with no areas of damage noted. The fuel tank is properly secured to the vessel, and cannot move around in the aft locker.

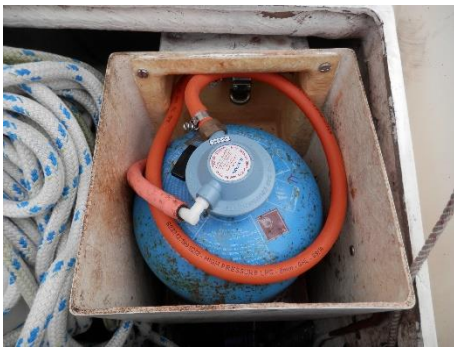
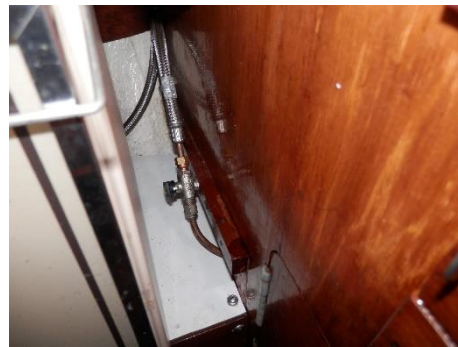
The gas system was professionally inspected in 2018. This certificate expired in April 2019. The orange rubber gas hose (dated 09/2018), regulator, copper piping where visible, stop valve and braded hose, were all found to be in a good condition.

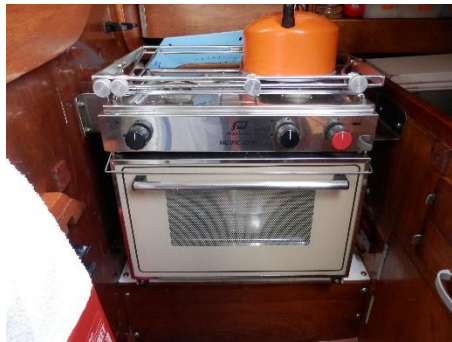
The Plastimo Pacific 2000 oven was found to be in a good condition, with no areas of damage or corrosion noted.

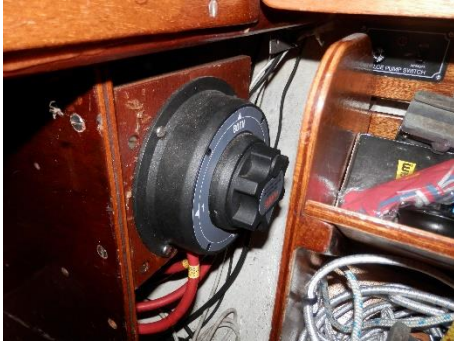
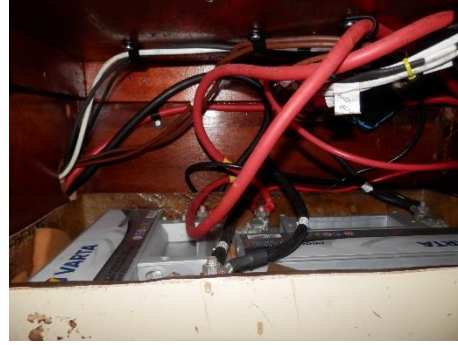
The vessel has two batteries fitted onboard. These are both located below the chart table. Both batteries look to be in a good condition, with no signs of any leaking. Both batteries are housed and vented correctly.

The two batteries are connected to one large isolator switch. The isolator switch is located below the chart table.

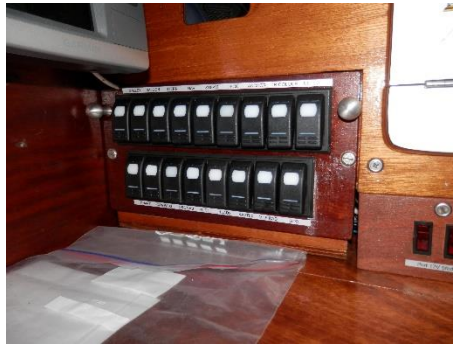
A switch board is located above the chart table.

During the survey, every item on the switch board was tested. There were no issues with the switchboard, and everything worked as it should. The masthead navigation light could not be seen working due to the bright conditions.

- Test the masthead navigation light in darker conditions.

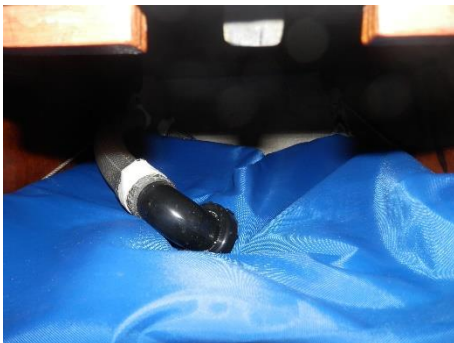
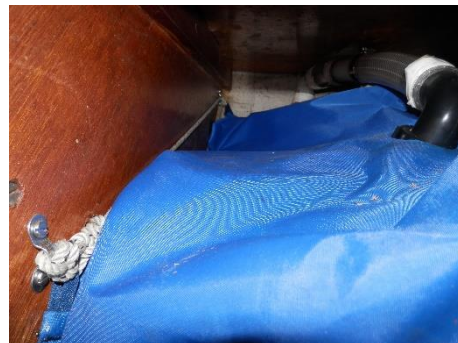
Two 50L Plastimo "soft" water tanks are fitted to [REDACTED]. The tanks are located under either side of the saloon. The tanks externally were found to be in a good condition, with no signs of water leaking from the tanks into the bilges.

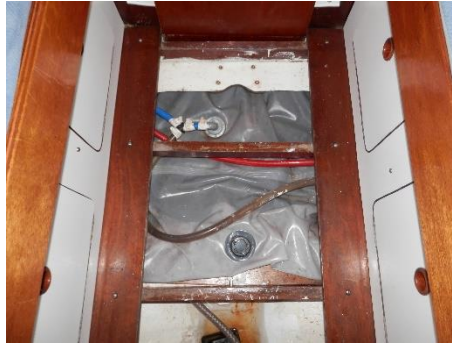
There is a 55L Osculati soft water waste tank located below the saloon sole boards. The tank was found to be in a good condition where visible. The tank is drained using a foot pump, mounted below the saloon sole boards. The pump was tested and found to be working correctly during the survey.

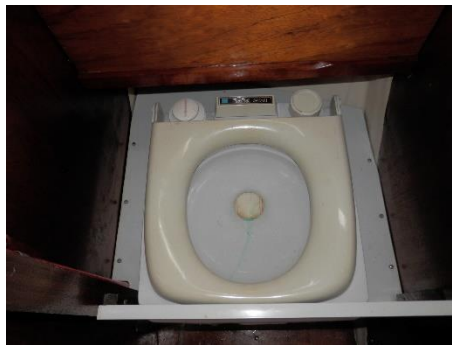
There is a Safari chemical toilet system fitted to this yacht. The toilet was found to be in a good condition, with no signs of leaking noted. The toilet is correctly mounted to the vessel.

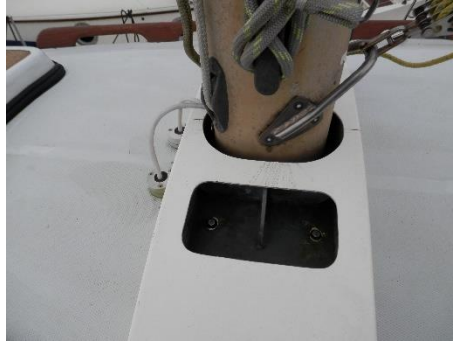
The mast is stepped by a galvanised steel deck plate and supported internally by the plywood main bulkheads. The mast step was found to be in a good condition, with no signs of cracking, distortion or stress related marks.

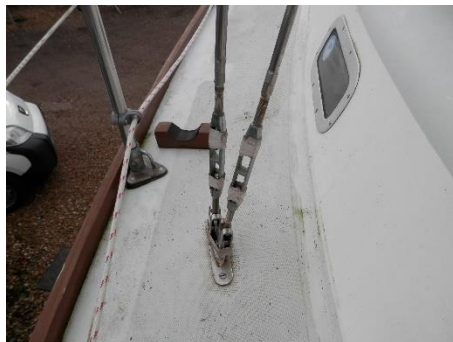
Bottle screws are fitted at the base of each shroud. All are correctly fastened with split pins.

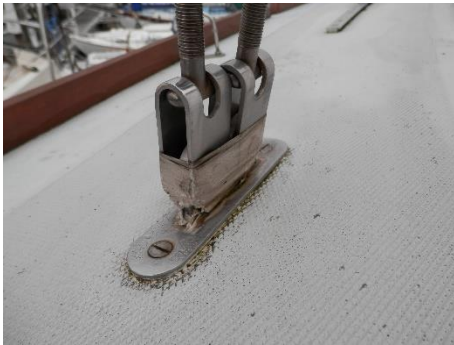
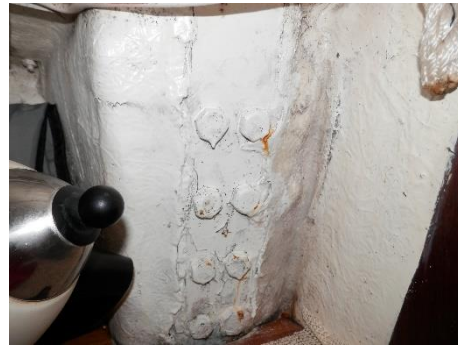
The starboard side shroud chainplate was originally glassed into the hull. The chainplate has been uncovered. Minor rust staining is emitting from the chainplate. I recommend that the deck cover plate is re-bed using fresh bedding compound.

- Re-bed the starboard side shroud deck plate with fresh bedding compound.
