Beneteau Gran Turismo 38 'Speciale'

Type of vessel: Beneteau Gran Turismo 38 'Speciale'.

Date of Survey: 10/08/2022

Survey was conducted for [REDACTED] for the purpose of Pre-Purchase, Condition, and Valuation by Henry Bettle MCMS AMRINA AMIMarEST BEng, Marine Surveyor.

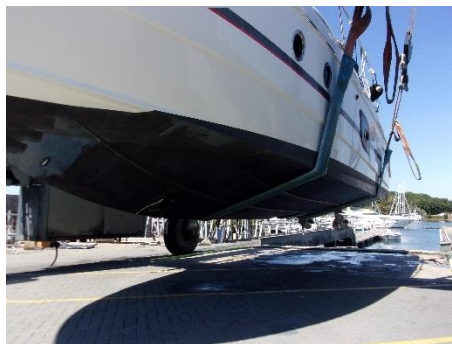
The underwater area of the hull was found to be coated with a black antifoul. The antifoul was found to be in a good condition overall, with only minor areas of flaking paint noted due to the pressure washing for the survey. The antifouling was applied in 04/2022. The hull was tapped over at random in its entirety with a small rubber hammer, and there were no signs of any voids or delamination detected. No visual signs of osmosis blistering, or wicking, were noted during the survey.

Moisture readings: Moisture readings were taken using a Tramex Skipper 5 randomly over the entirety of the hull below the waterline. It must be noted that the hull was still damp when the moisture readings were taken. If the hull was left to dry out for 48 hours, I would expect the moisture readings to be lower. Readings ranged from 10 to 20 on the portside, and 13 to 26 on the starboard side (averaging 16.6 on the portside and 20.0 on the starboard side). Readings of 14 and below are considered good, readings of up to 18 are considered acceptable, and readings of 18 and above are considered high. The readings taken on the 10/08/2022 were found to be acceptable to high. I suggest that the readings would decrease considerably if the vessel was allowed to dry out properly.

Due to the fact that there were no signs of osmosis blistering on the hull below the waterline, I suggest that the moisture readings taken on the 10/08/2022 are not a concern to the vessel at this time.

Wintering the vessel ashore yearly will help to prevent the moisture readings within the hull below the waterline from increasing further.

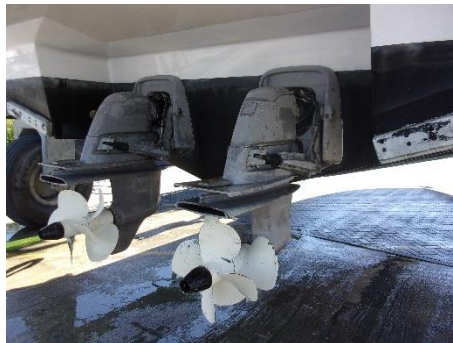
Sterndrives: The vessel is fitted with two Volvo Penta sterndrives. Both sterndrives were found to be in a good condition overall. No areas of corrosion, or damage due to grounding, were noted during the survey.

Bare metalwork was found on both sterndrives. This is most likely due to the pressure washing for the survey. I recommend that both sterndrives should be sanded, primed, and re-antifouled in the near future.

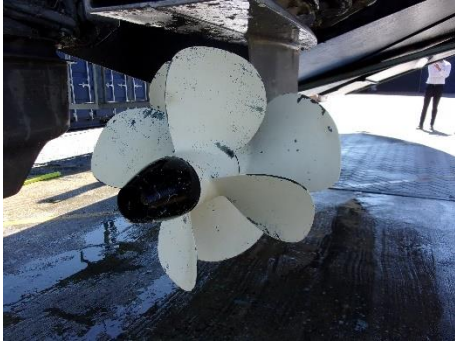
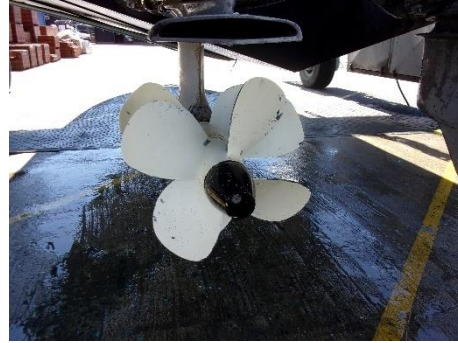
Propellers: The vessel is fitted with four Volvo Penta Marine propellers (two 3-bladed and two 4-bladed). All propellers were found to be in a good condition overall, with no signs of galvanic corrosion or pitting noted during the survey. No chips in the propeller foils, due to fouling, were noted. All propellers have been painted. This was found to be flaking off. All propellers would benefit from being lightly sanded and re-painted for the following season.

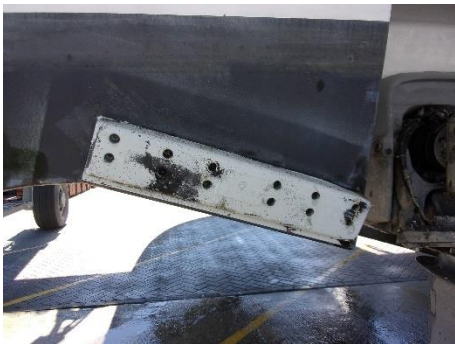
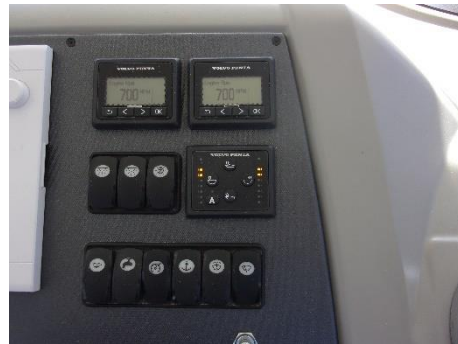
Trim tabs: The Volvo Penta interceptors fitted to [REDACTED] were found to be in a fair condition overall, with no signs of corrosion or damage noted during the survey. The hydraulics were tested during the survey and were found to be working well.

However, when testing the interceptors, a fault with the portside interceptor kept on flashing up (error code 4), indicating that the portside interceptor was getting stuck. I recommend that the fault with the portside interceptor is inspected further and resolved.

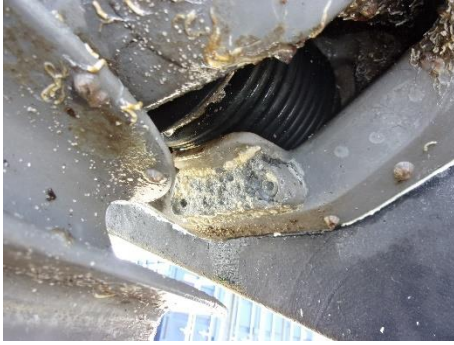
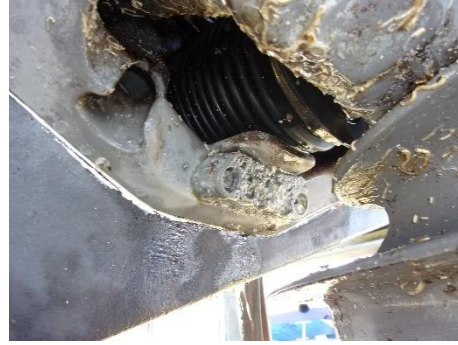
Both transom shield anodes were found to be in a depleted condition and will need to be replaced within the next 6 months. All other anodes onboard were found to be in a good condition and will last another 6 months at least.

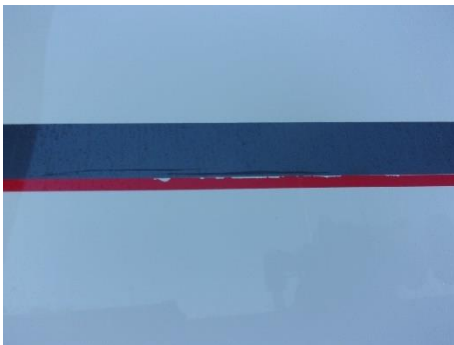
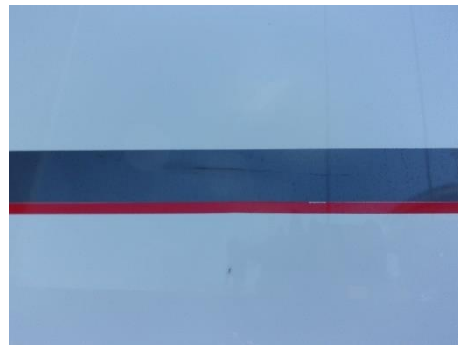
The grey and red chine stripes were found to be in a fair condition overall, with cosmetic scratches and scuffs noted on both sides of the vessel.

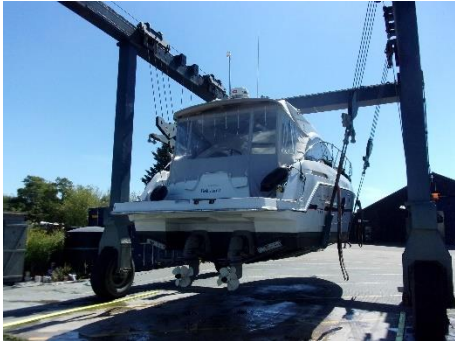
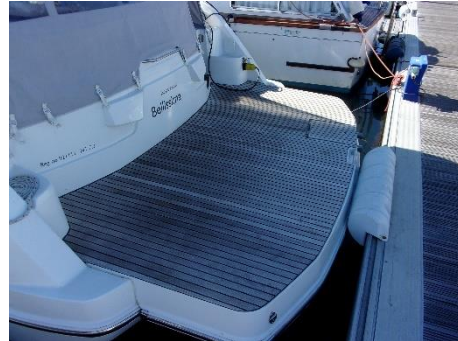
Transom: The transom and bathing platform were both found to be in a good condition overall, with no areas of structural damage noted.

The bathing platform teak decking was found to be in a good condition, with no evidence of damage or lifting noted.

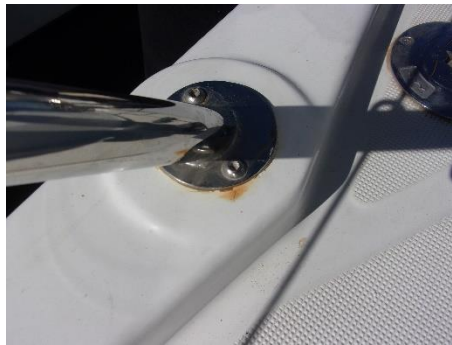
Below the starboard side 5<sup>th</sup> stanchion from the bow, minor rust staining was found. Moisture readings of the area of rust staining were taken and found to be low. I therefore recommend that the rust staining is a cosmetic issue only at this time.

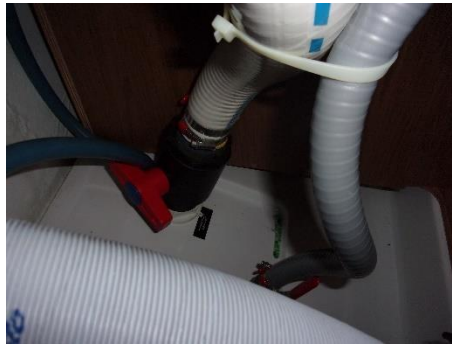
The toilet inlet seacock was found to be very stiff to operate. I recommend that the toilet inlet seacock is serviced or replaced.

- I recommend that the heads inlet seacock is serviced or replaced.

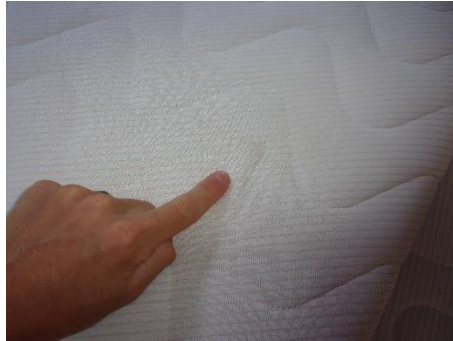
The v-berth mattresses were found to be in a good condition overall. The portside mattress was found to be marked on the top. This is a cosmetic issue only.

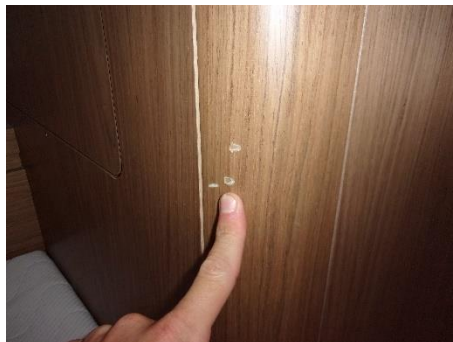
The interior woodwork and headlining were found to be in a good condition overall. Within the aft cabin, three chips to the woodwork were noted. All were found to be a cosmetic issue only.

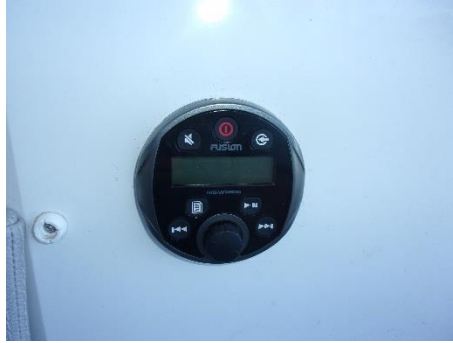
The original fusion stereo system was not working during the survey. The system has been replaced with a new stereo, mounted on the portside of the saloon.

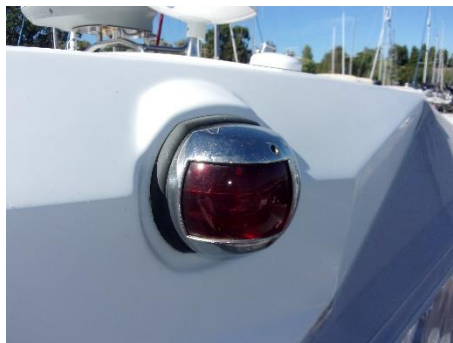
The portside navigation light was found to not be working during the survey. I recommend that the portside navigation light is serviced or replaced.

- Both the v-berth and galley fire extinguishers should be replaced due to their ages.
- I recommend that all lifejackets onboard are serviced.
- I recommend that the portside navigation light is serviced or replaced.
