Marine Yacht Surveyor

Moody 346

Type of vessel: Moody 346 Fin Keel GRP sloop

Survey was conducted for [REDACTED] for the purpose of pre-purchase, condition and valuation by Henry Bettle AMSCMS AMRINA AMIMarEST BEng, Marine Surveyor.

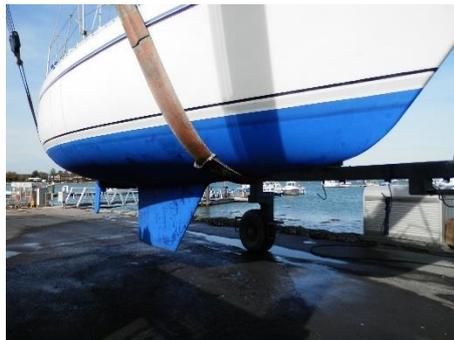
The underwater area of the hull was found to be coated with a blue antifoul. This was found to be in a good condition overall. The hull was tapped over at random in its entirety with a small hammer, and there were no signs of any voids or delamination detected.

There were no signs of blistering on the GRP hull. This is a good indication that the hulls' moisture levels are relatively low, and that osmosis is not occurring at this time.

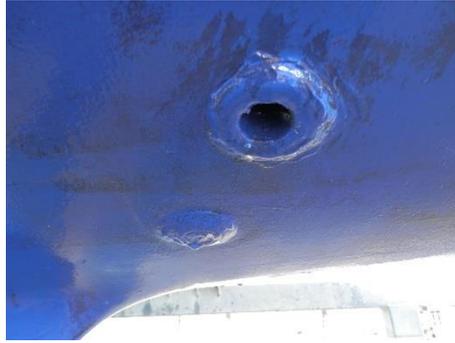
Moisture readings: Moisture readings were taken using a Tramex Skipper Plus randomly over the entirety of the hull. The weather on the ██████████ was dry and cold. Readings ranged from 14 to 22 on the port side, and 13 to 22 on the starboard side (average 16 on port and 16.8 on starboard). Readings of under 18 are considered acceptable and readings below 14 are considered good. There are no signs of blistering forming on the hull below the waterline at this time, which would be a clue that osmosis is occurring. The moisture readings taken on the ██████████ are acceptable, and not an issue to the vessel at this time. I recommend that the moisture readings would be lower if the vessel was left to dry out properly on land for 48 hours. The vessel would benefit from being wintered ashore each year for five to six months, to help prevent the moisture levels within the hull increasing further.

Skin Fittings: All skin fittings below the waterline were found to be in a good condition, with no signs of galvanic corrosion on the fittings.

- The vessel would benefit from being wintered ashore each year for five to six months, to help prevent the moisture levels within the hull increasing further.

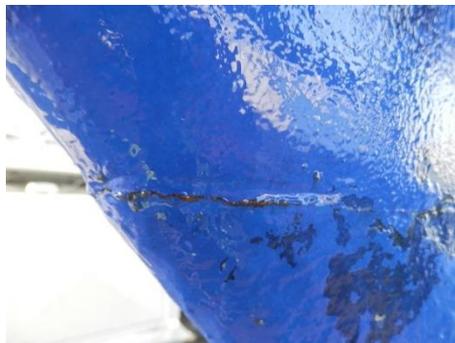
Hull/Keel join: The hull-keel join was found to be in a good condition overall. There is a small amount of corrosion emitting from the front of the keel join. This is a minor issue at this time.

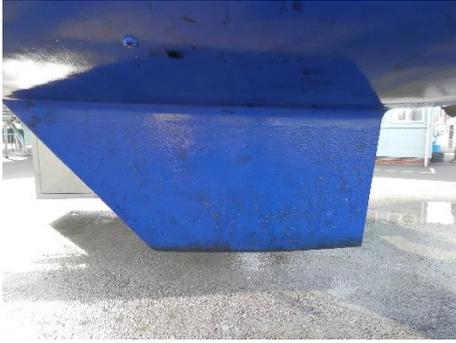
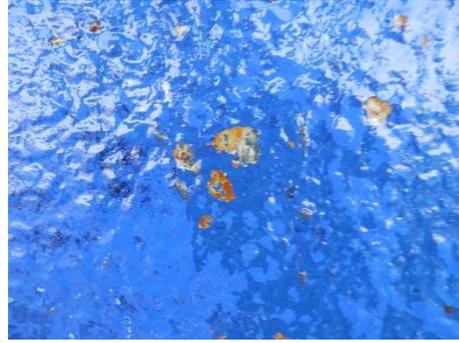
The keel has areas of surface corrosion over its entirety. I recommend that the keel is sanded back to good metal, treated with a rust killer, epoxy coated, primed, and then antifouled. This should prevent further corrosion of the keel.

There are no signs of stress cracking or damage to the hull around the keel mounting.

- The keel is sanded back to good metal, treated with a rust killer, epoxy coated, primed, and then antifouled.
- The forward keel fastening should be withdrawn from the vessel, on land, and assessed in its entirety. The keel fastening will most probably need to be replaced.
- All keel bolts, other than the forward most bolt, should be cleaned and painted with a rust killer. A layer of protective paint can then be applied to each.

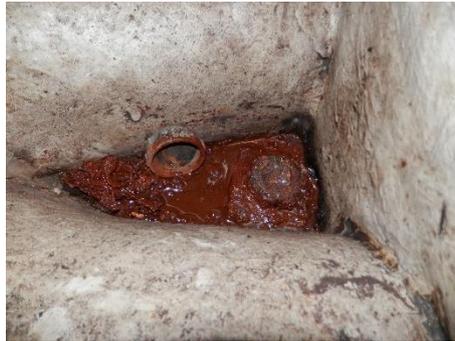
The forward-most keel fastening was found to be heavily corroded and sitting in salt water. This suggests that the keel fastening is "weeping" when under considerable load. The keel fastening should be withdrawn from the vessel, on land, and assessed in its entirety. The keel fastening will most probably need to be replaced.

- The forward keel fastening should be withdrawn from the vessel, on land, and assessed in its entirety. The keel fastening will most probably need to be replaced.
- The toilet outlet, galley drain, and shower pump drain seacocks should be either serviced or replaced, depending on their conditions internally.

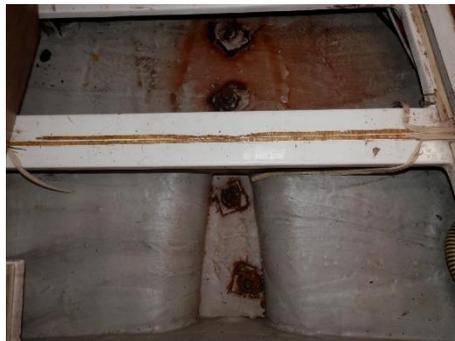
All other keel fastenings were found to be in a serviceable condition, with surface corrosion covering all of them. I recommend that all keel fastenings, other than the front fastening, are cleaned and painted with a rust killer, to prevent further surface corrosion.

If the keel needs to be dropped in order to replace the front fastening, it may be worth replacing all fastenings at the same time.

- All keel bolts, other than the forward most bolt, should be cleaned and painted with a rust killer. A layer of protective paint can then be applied to each.
- The anode wiring is checked for breakages and replaced as necessary.
- Remove the fuel tank from the vessel. Sand of the corrosion and rust treat the tank. If the corrosion is more serious, the tank may need to be professionally repaired or replaced.
- Replace the orange gas piping in the gas locker.
- Replace the gas regulator.
- Replace the braded hose behind the gas cooker.
- The stern navigation light is serviced or replaced.
- All fire extinguishers should be replaced onboard.

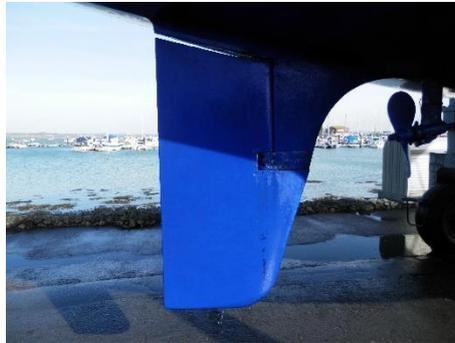
Rudder: The vessel's rudder is a semi-spade, skeg hung type and is constructed of GRP. This is in good condition overall, with no signs of grounding or damage.

Moisture readings were taken at random locations across the entirety of the rudder and were found to range from 27 to off the scale. There are no signs of blistering on the rudder at this time, and high moisture readings are common in this design. I recommend that the rudder is monitored yearly for any signs of blistering developing.

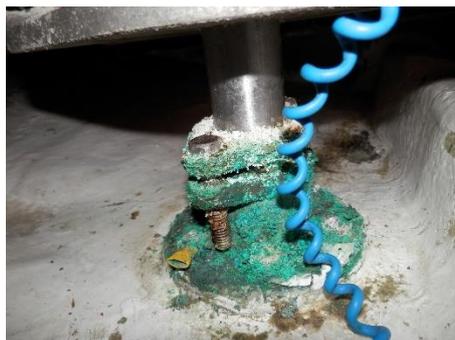
Steering system: [REDACTED] is fitted with wheel steering. This was found to be in a fair condition overall, with little to no play in the system noted. Internally, the steering system is in a fair condition. The wire connecting the base of the steering system to the pear anode has snapped. This is causing the lower bronze section of the fitting to corrode. The anode should be re-attached to the lower steering system, to prevent further corrosion. The corrosion should be cleaned off the rudder post gland.

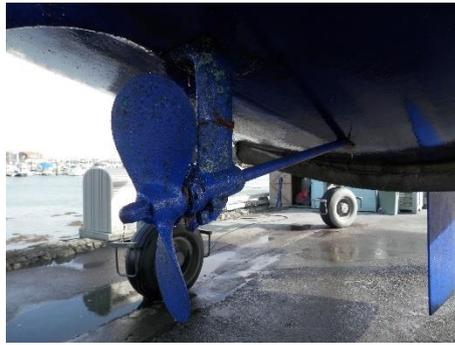
Propeller: The vessel is fitted with a 2-bladed bronze propeller, attached to a conventional shaft running through a P-bracket and cutlass bearing. There is also a rope cutter fitted. The propeller and shaft were found to be in a good condition overall, with no signs of galvanic corrosion, pitting, or damage due to fouling. The rope cutter was mounted correctly.

The cutlass bearing is in a good condition, with little to no play noted.

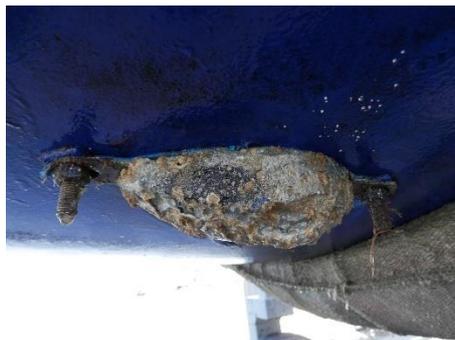
The "P" bracket is beginning to show signs of galvanic corrosion.

Anodes: A pear-shaped anode is bolted to the hull on the starboard side. The anode is depleted and will need to be replaced for the next season. The anode should be electrically bonded to the engine block, "P" bracket, battery negative terminals and steering system. I tested for electrical continuity between the anode and the propeller with a multimeter and found no connection. The anode is also not connected to the steering system.

The anode wiring should be checked for issues and replaced if necessary.

- The rudder is monitored yearly for any signs of blistering developing.
- The pear-shaped anode should be replaced for the next season.
- The anode wiring is checked for breakages and replaced as necessary.

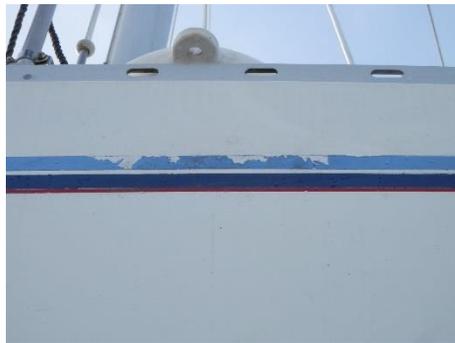
Mooring damage /Abrasion: There are areas of minor cosmetic damage over the entirety of the topsides, more notably on the portside amidships. These are not a structural concern. There are no major cracks or scratches on the hull.

The strake stripes were found to be damaged on the portside amidships. This is a cosmetic issue only.

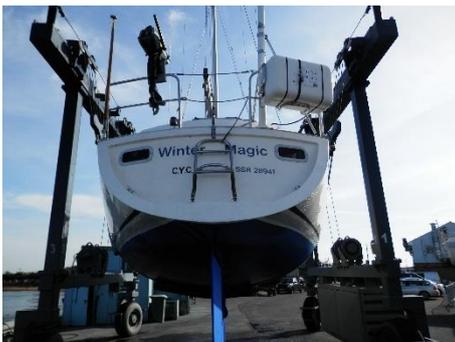
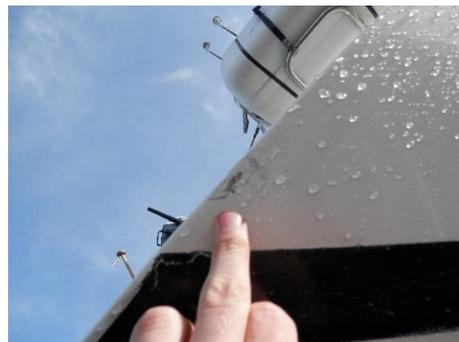
Transom: The transom is in a good condition overall. There is an area of gelcoat cracking on the starboard side of the transom. This is a cosmetic issue only.

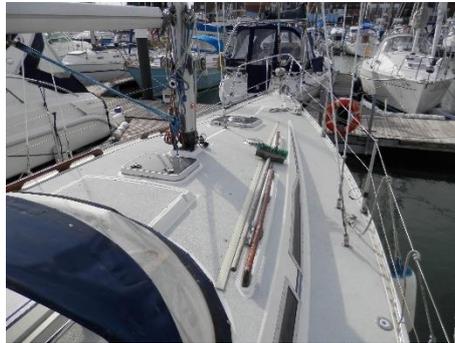
The deck and coachroof of the vessel still have their original white gelcoat. This is in a good condition. The non-slip deck paint applied is in a good condition. There are no signs of pinhead blistering on the topsides.

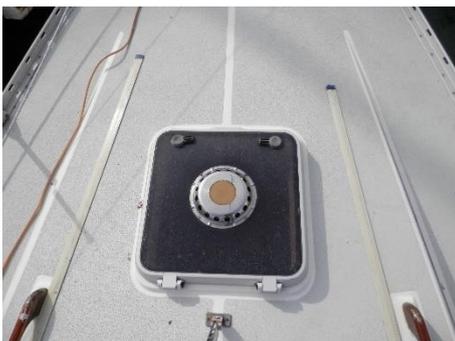
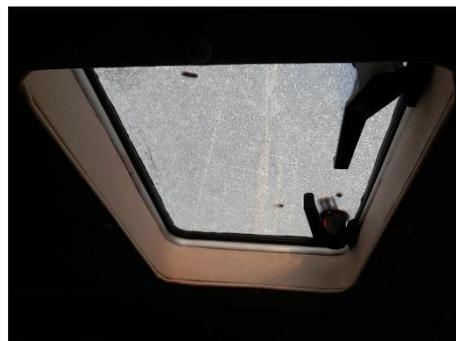
Hatches: None of the hatches onboard show any signs of leaking or corroding of the frames and were found to be in a good condition overall. The rear berth, saloon and V-berth hatches are all crazed. This is not a structural issue however and merely cosmetic.

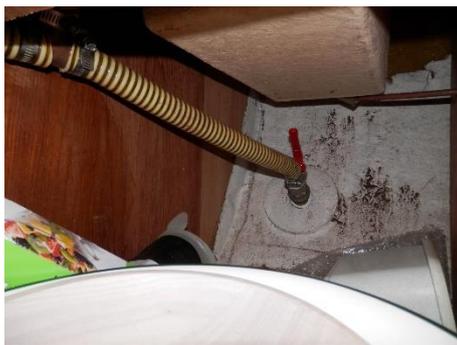
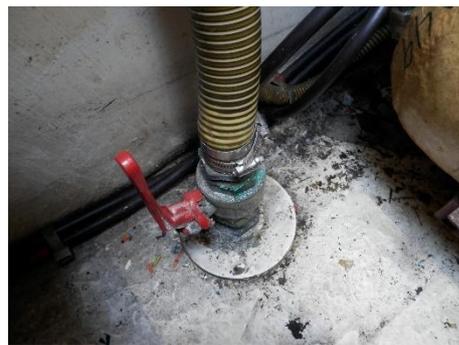
The heads outlet seacock was found to be very stiff to operate. The galley sink drain, and shower drain seacocks were both found to be seized. The three seacocks should be either serviced or replaced, depending on their conditions internally.

- An automatic bilge pump should be fitted.
- The toilet outlet, galley drain, and shower pump drain seacocks should be either serviced or replaced, depending on their conditions internally.

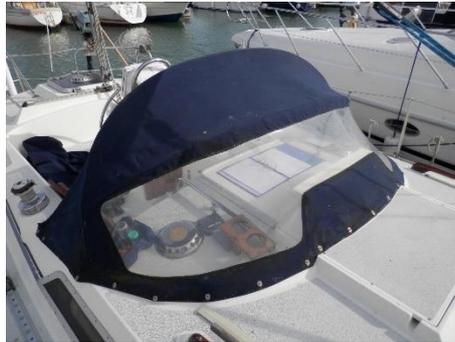
The vessel is fitted with a spray hood, wheel cover and sail cover. The sprayhood is in a serviceable condition and could benefit from being professionally cleaned and serviced to increase its life span. The sail cover is located in the V-berth of the vessel and was found to be in a good condition. The wheel cover was found to be in a good condition.

- The sprayhood would benefit from being professionally cleaned and serviced to increase its life span.

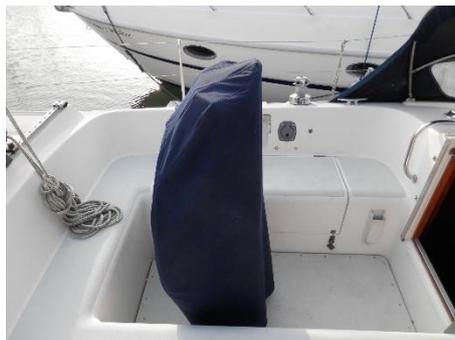
The vessel benefits from a spacious and safe centre cockpit. There is a bilge pump fitted to port of the cockpit. This was tested and found to be working well. Large cockpit scuppers are fitted for drainage. The vessel has wheel steering. One large cockpit locker is to port and is in a clean and tidy condition. The gas bottles are located in a small locker to port of the cockpit.

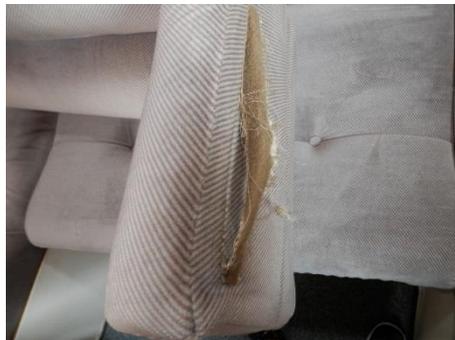
The upholstery is in a good condition overall. The connecting Velcro was coming away from the starboard side saloon cushions. This should be reattached.

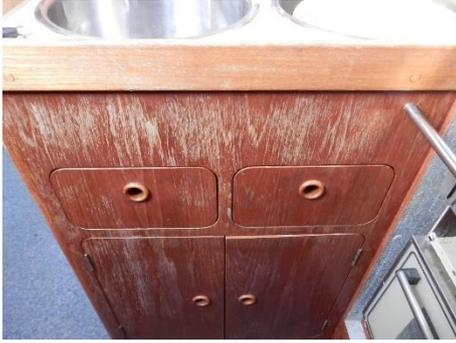
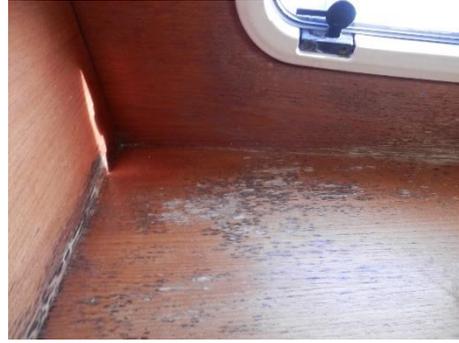
The galley woodwork is showing signs of UV damage. This should be sanded and re-varnished.

There is an area of water damage to the aft cabin below the portside small hatch. This is a cosmetic issue only.

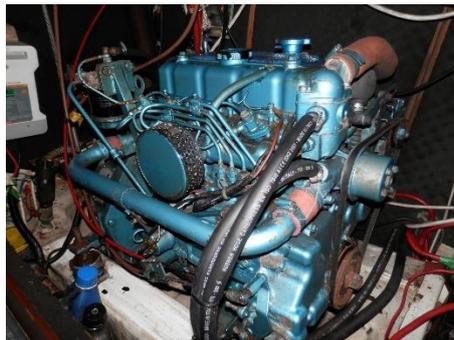
The engine was started during the survey. The engine took a while to start but ran well when running. The engine and gearbox oils were found to be at the correct levels. The engine oil is dirty and should be replaced.

Externally, the engine is in a fair condition, with minor areas of flaking paint and surface corrosion noted. The piping and filters on the engine were found to be in a good condition.

The exhaust is in a good condition, having been replaced in 2019 (piping, manifold and elbow).

The engine was last serviced in 2018, according to the onboard paperwork. I recommend that the engine is serviced for the next season.

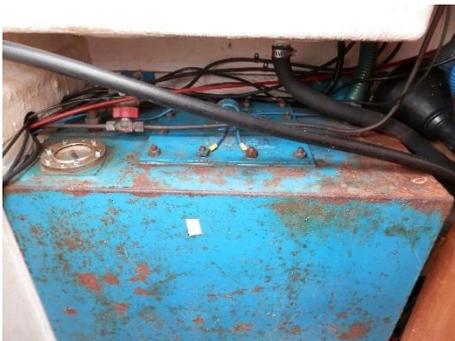
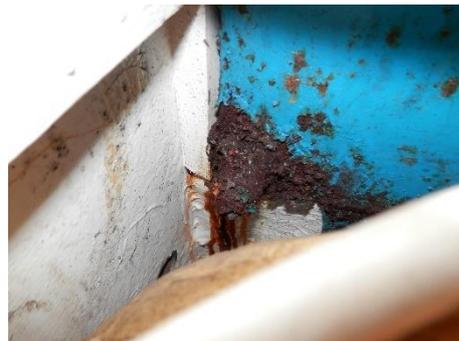
There is a steel fuel tank fitted in the cockpit locker. The tank is accessible through the cockpit locker. The tank is in a serviceable condition overall. At the bottom of the tank (forward starboard side) there is an area of corrosion. There is no evidence that the tank is leaking at this time. There is a medium amount of surface corrosion covering the majority of the tank.

I recommend that the tank is removed from the vessel, cleaned off and rust treated. The tank can then be painted with a protective paint. If the corrosion on the bottom of the tank is more serious, the tank may need to be professionally repaired or replaced.

- Remove the fuel tank from the vessel. Sand off the corrosion and rust treat the tank. If the corrosion is more serious, the tank may need to be professionally repaired or replaced.
- Service or replace the diesel heater.

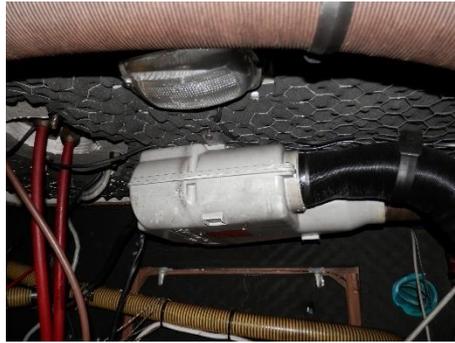
A diesel heater has been fitted to the engine bay of the vessel. This was tested during the survey. The diesel heater fan switched on, but the heater produced no heat. The diesel heater will need to be serviced or replaced.

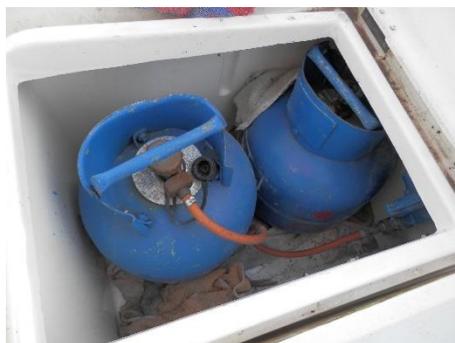
The orange gas piping in the gas locker was found to be out of date. This should be replaced. The regulator is old and should also be replaced.

The braided hose, located behind the gas cooker, is old and should be replaced.

- Replace the orange gas piping in the gas locker.
- Replace the gas regulator.
- Replace the braded hose behind the gas cooker.

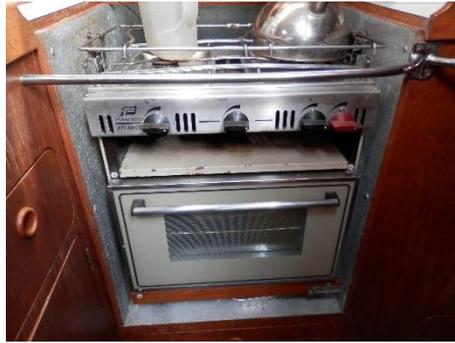
The Plastimo Atlantic gas cooker was found to be in a serviceable condition, with areas of surface corrosion and damage noted. It may be wise to replace the cooker in the future.

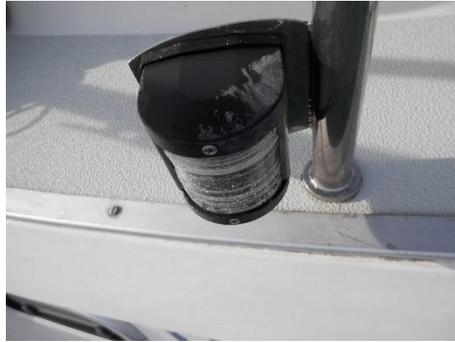
The stern navigation light was not working during the survey. This should be serviced or replaced. The masthead navigation light could not be seen working during the survey due to the bright conditions.

- The stern navigation light is serviced or replaced.
- The masthead navigation light is tested in darker conditions.

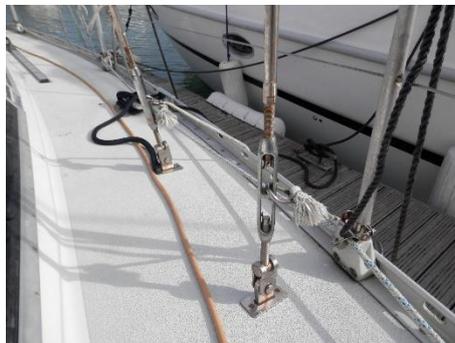
The forestay and backstay chainplates were found to be in a good condition. The shroud chainplates are located behind the saloon woodwork and cannot be inspected without removing the interior. I recommend that the woodwork is removed to inspect the chainplates properly.

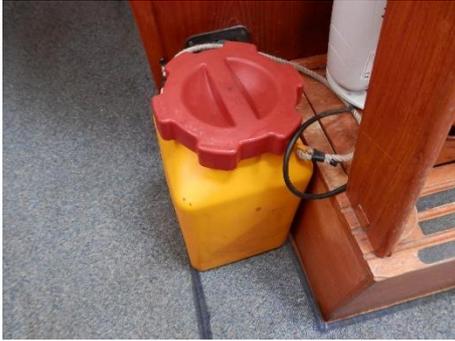
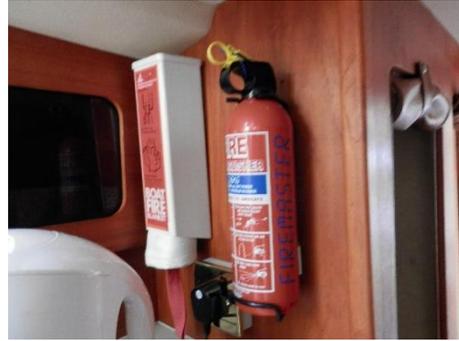
Item	Location	Condition
Fire extinguishers	1 (Galley), 1 (saloon), 2 (engine bay)	All expired.
Life Jackets	None found	-
Flares	Either side of saloon steps	Expire 2012, 2007 and 1986.
Icom VHF	Chart table	Good
Icom handheld VHF	Chart table	Good
Furuno GPS	Chart table	Good
Target Navtex	Chart table	Very faint display.
Raymarine wind	Cockpit	Good
Stowe depth and speed	Cockpit	Good
Clipper log	Cockpit	Good
Furuno Plotter	Cockpit	No GPS fix
Autohelm 4000	Chart table	Good
Horse show Life buoy (2)	V-berth	Good
Throwline	V-berth	Good
Liferaft	Pushpit	Due a service 2014

- All fire extinguishers should be replaced onboard.
- A set of life jackets should be purchased for the vessel.
- The flares onboard should be safely disposed of and a new set purchased, suitable for the sailing conditions planned.
- The chart plotter, mounted to the helm position, would not find a GPS fix. Further investigation into this should be undertaken.
- The liferaft will need to be professionally serviced or replaced.
