Jeanneau NC9

Type of vessel: Jeanneau NC9.

Vessel Lying: Swanwick Marina, Hamble.

Survey was conducted for Mr Ed Davies for the purpose of pre-purchase, condition and valuation by Henry Bettle AMSCMS AMRINA AMIMarEST BEng, Marine Surveyor.

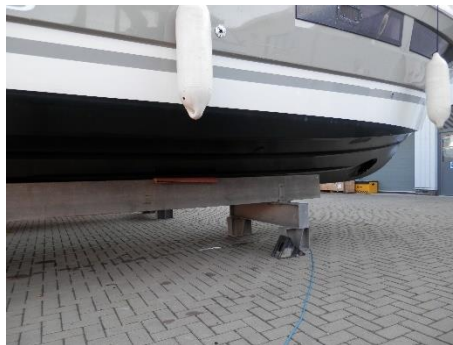
The underwater area of the hull was found to be coated with a black antifoul. The antifoul has been applied well and shows no signs of flaking. The hull was tapped over at random in its entirety with a small rubber hammer, and there were no signs of any voids or delamination detected. No visual signs of osmosis blistering were found on the hull.

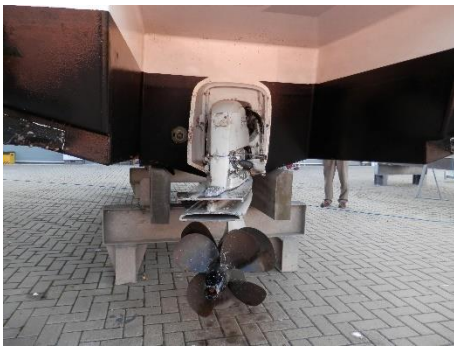
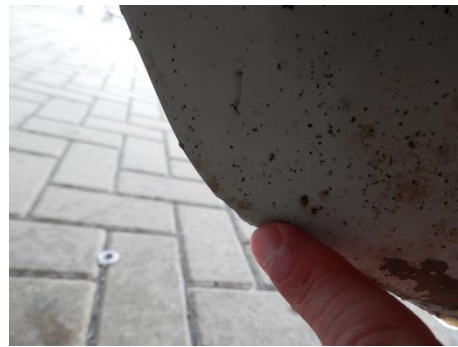
Sterndrives: The vessel is fitted with one Volvo Penta sterndrive. The sterndrive was found to be in a good condition overall, with no major issues noted. The stern drive paint is flaking off. This is a cosmetic issue only. No areas of corrosion on the sterndrive were noted.

There is a small (0.5cm diameter) chip out of the lower Leading edge of the sterndrive. This is not an issue to the structure of the sterndrive.

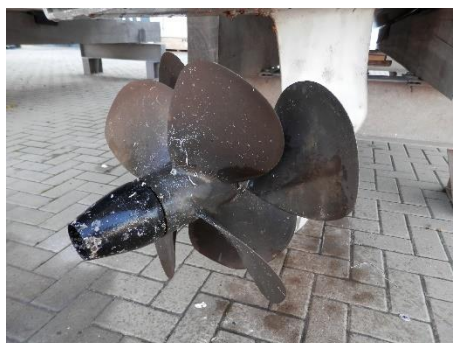
Propellers: The vessel is fitted with two stainless steel propellers. Both propellers were found to be in a good condition overall, with no signs of galvanic corrosion or pitting. No chips in the propeller foils, due to fouling, were noted.

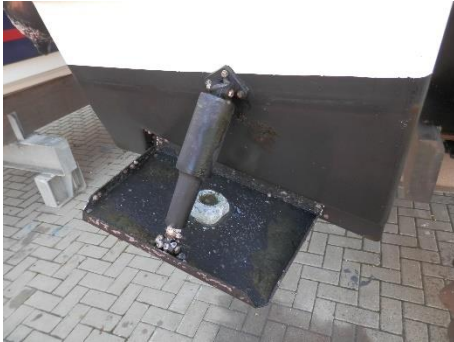
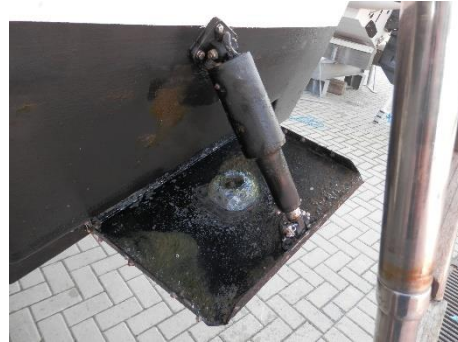
Trim tabs: The trim tabs were found to be in a good condition overall, with no signs of corrosion noted. Both trim tabs have a circular anode bolted to them. These were found to be in a depleted condition, and should be replaced for the next season.

The trim tabs hydraulics were tested during the survey and found to be working well.

Anodes: As mentioned above, the trim tab anodes should be replaced for the next season.

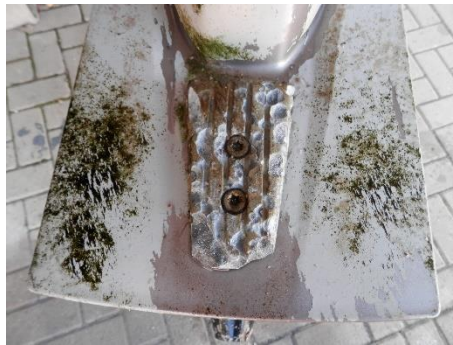
There is a circular anode bolted to the hull on the portside of the sterndrive. This was found to be in a depleted condition and should be replaced for the next season.

The sterndrive main anode was found to be in a depleted condition and should be replaced for the next season.

- All anodes onboard should be replaced for the next season.

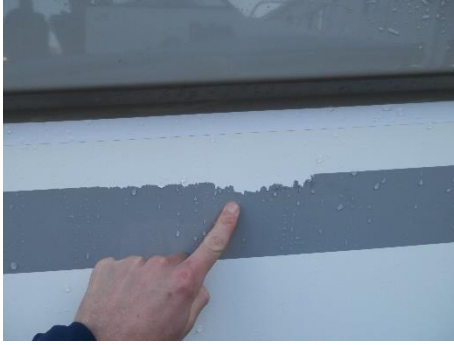
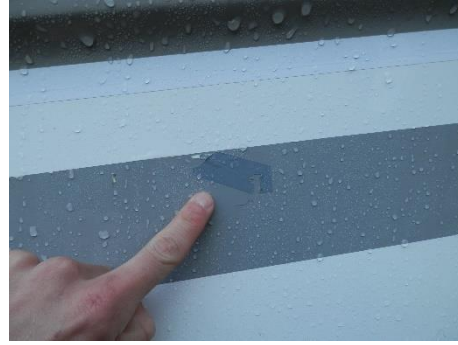
The grey boot stripe was found to be in a fair condition overall. There is an area of damage to the stripe on the starboard side of the vessel (amidships), and on the starboard side further forward. These are both cosmetic issues only.

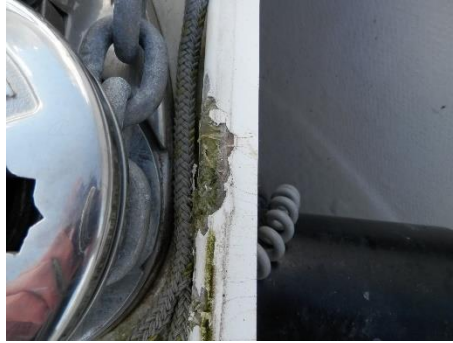
Mooring damage /Abrasion: There is an area of damage to the gelcoat and fibre glass matting on the portside of the anchor locker, between the anchor locker and anchor windlass. The damage is not a structural issue at this time. However, the fibreglass matting is showing in this area, which will allow moisture ingress into the deck over time. This area of damage should be sanded back to good GRP, then rebuild using layers of fibreglass and resin. The area can then be finished with a colour matched white gelcoat. A stainless-steel patch could be fastened to the repaired area, to prevent any future damage from the anchor chain.

- The area of damage on the portside of the anchor locker should be sanded back to good GRP, then rebuild using layers of fibreglass and resin. The area can then be finished with a colour matched white gelcoat.
- The chip on the portside of the bow roller should be filled with a gelcoat filler.

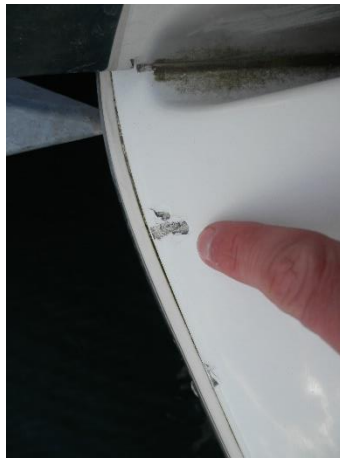
There is a small chip in the gelcoat on the portside of the bow roller. This is a cosmetic issue only at this time. The chip should be filled using a gelcoat filler.

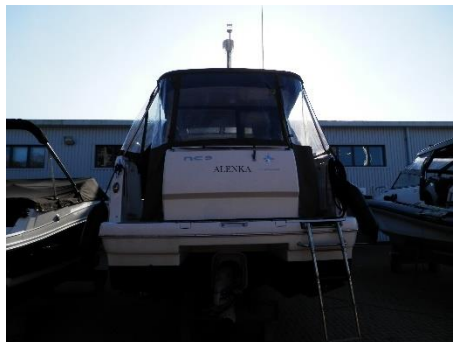
Transom: The transom is in a good condition overall, with no signs of collisions or stress cracking. The transom is in an end of season condition cosmetically and would benefit from being cleaned and polished.

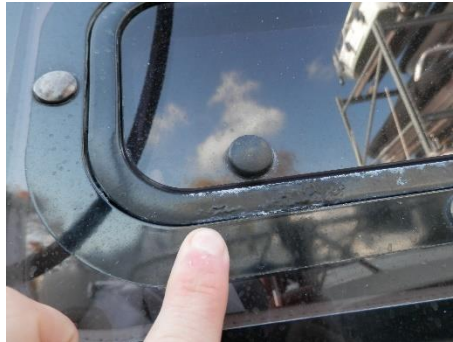
The amidships double berth small hatch frame is beginning to corrode on the outside. This is a cosmetic issue only at this time.

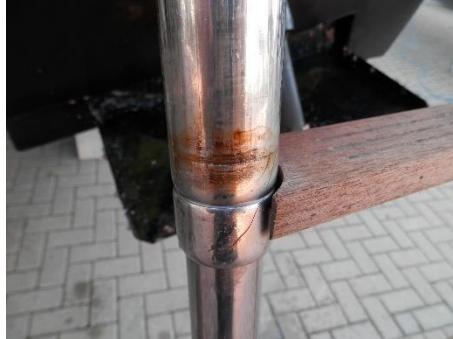
- Boarding ladder (areas of rust stain emitting from joins).
- Fuel and water filler caps.
- Fenders (7).
- Warps (4).

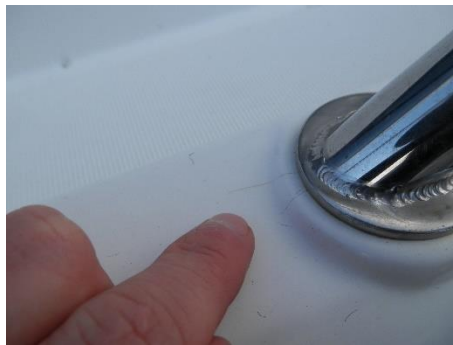
The second from aft stanchion on the portside was found to be "wobbly". This should be re-bed using fresh bedding compound to prevent leaking into the hull.

There is minor gelcoat cracking under the starboard side amidships stanchion mounting. This is a cosmetic issue only at this time.

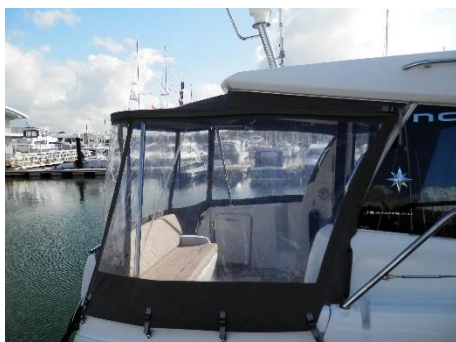
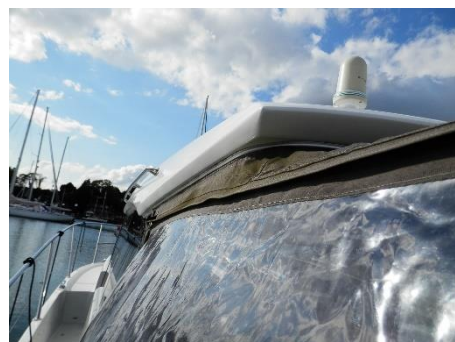
The vessel is fitted with a cockpit cover. The cover was found to be in a good condition overall, with no signs of tearing or damage noted. The top section of the cover is beginning to turn green with algae. The cover would benefit from being removed and professionally cleaned and protected.

- Have the top section of the cockpit cover professionally cleaned and protected.

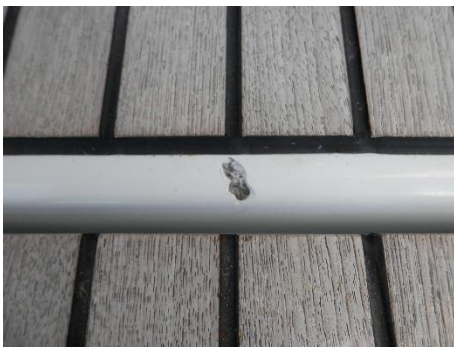
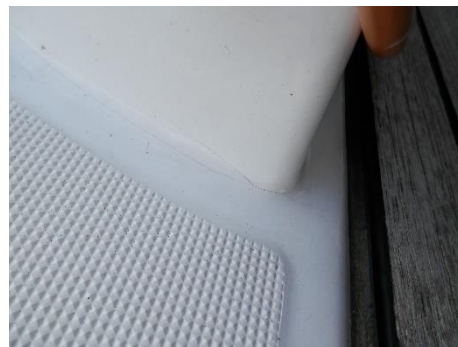
There is a small gelcoat chip aft of the engine bay hatch, in the middle of the cockpit. This should be filled with a gelcoat filler.

There is an area of gelcoat cracking around the portside aft corner of the cockpit. This is a cosmetic issue only.

- Fill the area of cockpit gelcoat damage with a gelcoat filler.

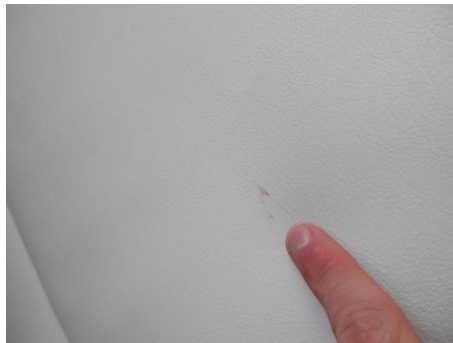
The upholstery is in a good condition overall, with one very small area of marking on the aft saloon seat cushion. The V-berth and amidships berth mattresses were found to be in a good condition.

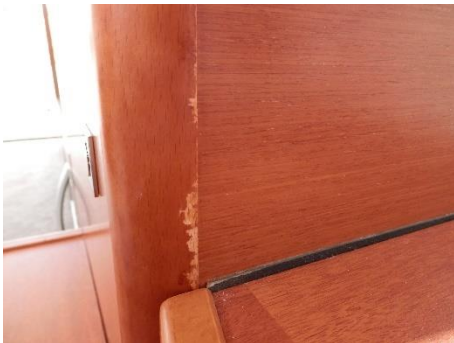
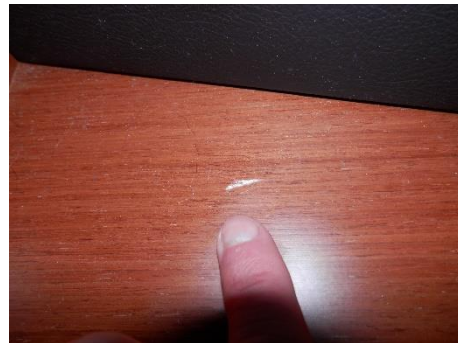
The interior woodwork and lining are in a good condition. There are five areas of minor scuffing and scratches noted to the interior woodwork. These were all found to be cosmetic issues only.

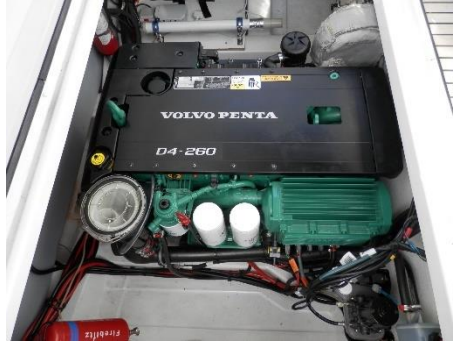
One Volvo Penta D4 260hp duo prop diesel inboard engine has been fitted to [REDACTED]. The engine is original to the yacht. The hours are 139, which is low. The engine number is A471435. The engine has been professionally serviced yearly, most recently in 26/03/2020.

The engine oil was found to be at the correct level. The oil is dirty and should be replaced for the next season.

- Replace the engine oil for the next season.

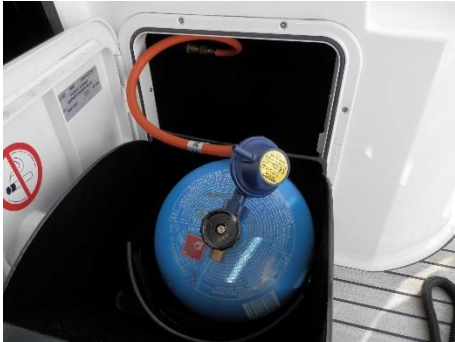
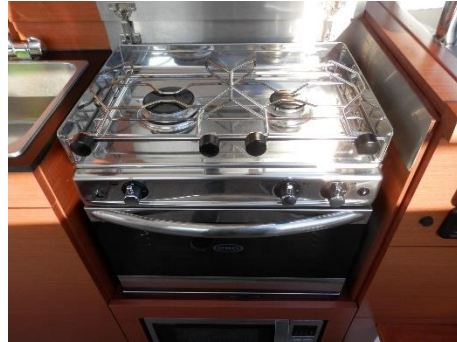
The orange rubber gas piping in the gas locker is due to be replaced in 2021. The regulator was found to be in a good condition.

The orange gas piping, connecting the shut off valve to the cooker, should be replaced with a braided hose.

- Replace the orange rubber gas piping behind the cooker with braided hose.

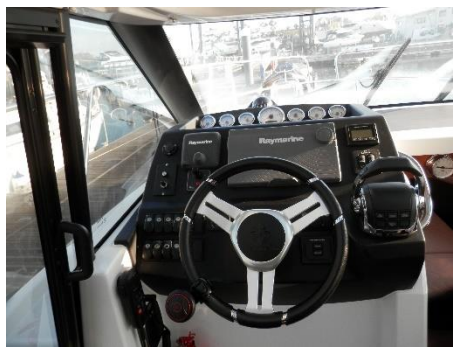
The Fusion 300 stereo system could not be found or made to operate.

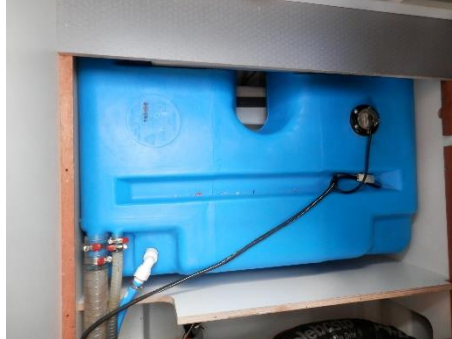
One 160 litre plastic water tank is located under the saloon. The internal condition of the water tank was not checked. Externally, the tank is in a good condition, with no signs of leaking or damage to the tank.

The water tank level gauge, mounted on the heads aft bulkhead, was reading empty during the survey. The tank should be filled to check if the gauge is working.

- Check whether the water tank gauge is working by filling the tank.
