Jeanneau Sun Odyssey 40

Type of vessel: Jeanneau Sun Odyssey 40 Fin Keel GRP sloop

Date of Survey: 20/09/2022

Survey was conducted for [REDACTED] for the purpose of Pre-Purchase, Condition and Valuation by Henry Bettle MCMS AMRINA AMIMarEST BEng, Marine Surveyor.

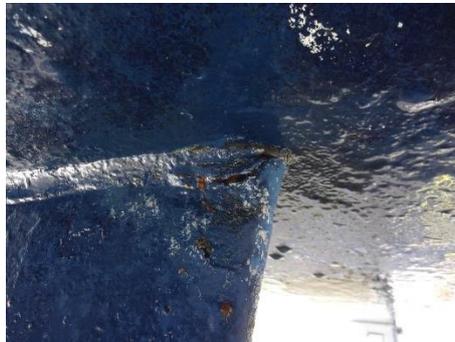
Hull/Keel join: The hull-keel join was found to be in a good condition overall, with no evidence of keel movement noted during the survey. A layer of sealant has been added to the outside of the hull-keel join to prevent corrosion of the join. This is beginning to peel off at the aft of the keel. I recommend that it would be wise to remove the sealant covering the outside of the hull keel join at the aft of the keel. The area of join can then be rust treated, protected, and coated with a new layer of marine grade sealant.

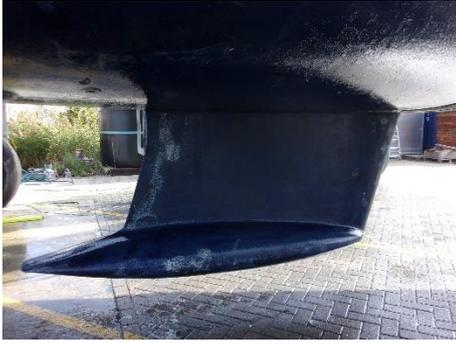
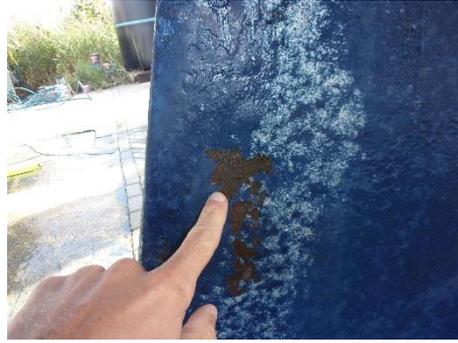
The keel itself was found to be in a good condition overall. Minor areas of surface corrosion were noted over the keel during the survey. Although only a minor issue at this time, I recommend that the areas of surface corrosion on the keel are sanded back to good metal, rust treated, and coated with layers of protective paint.

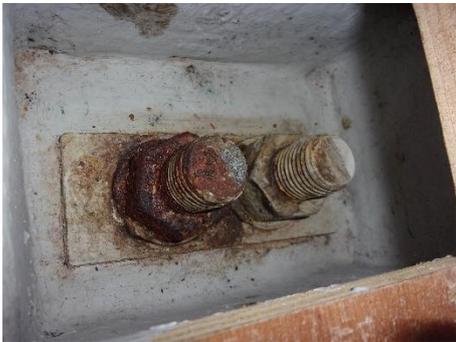
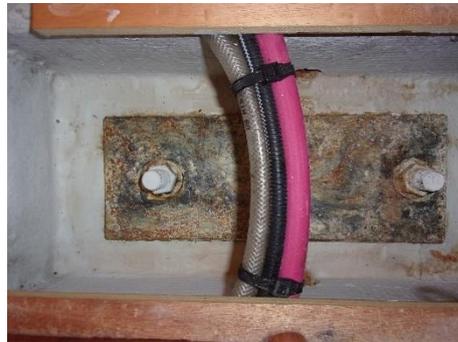
The portside forward keel bolt, as well as the two aft keel bolts, were found to be beginning to corrode. This is a minor issue only at this time. However, I recommend that it would be wise to rust treat and protect the portside forward and two aft keel bolts in the future.

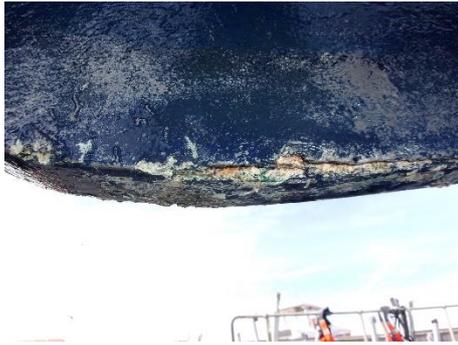
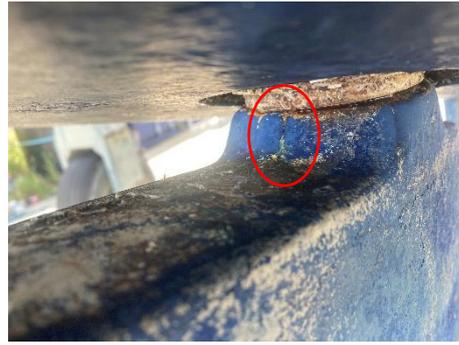
On the base of the rudder, evidence of grounding damage was noted. This has caused the rudder to delaminate in this area. This, overtime, will cause moisture ingress into the rudder, degrading the rudder core foam.

At the top of the rudder, surrounding the rudder post, gelcoat cracking was noted. This is further evidence that the rudder has hit the ground in the past.

I recommend that the rudder is removed from the vessel. The gelcoat cracking surrounding the rudder post can then be ground out and repaired. The damage to the base of the rudder can be ground out, and the rudder core inspected and dried. The bottom of the rudder can then be re-built using GRP.

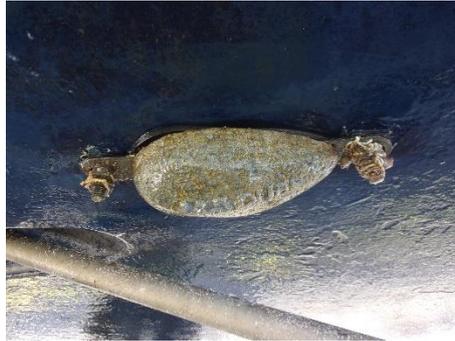
Anodes: The vessel is fitted with shaft anode and a pear-shaped anode. The shaft anode was found to be in a depleted condition and will most likely need to be replaced within the next three months. The pear-shaped anode was found to be in a good condition and should last another 6 months at least.

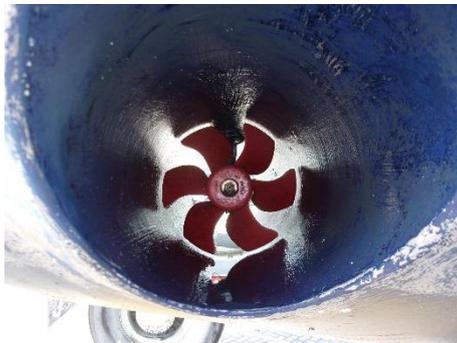
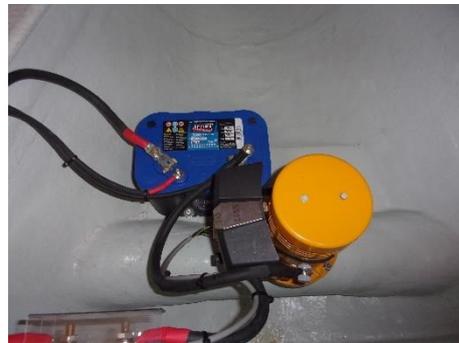
Bow thruster: A bow thruster has been fitted to the yacht in 2020. Externally and internally, the bow thruster was found to be in a good condition, with no areas of damage noted. However, the bow thruster could not be made to operate during the survey. I recommend that the faulty bow thruster is serviced.

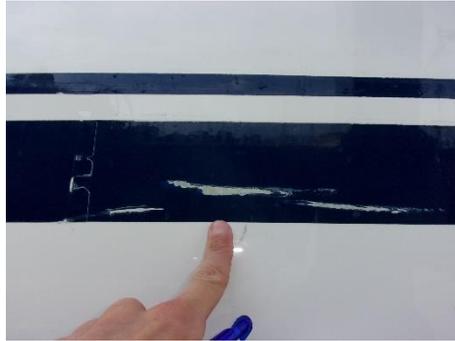
The boot and strake stripes were found to be in a cosmetically fair condition, with cosmetic scratches and scuffs noted on the starboard side amidships of the vessel.

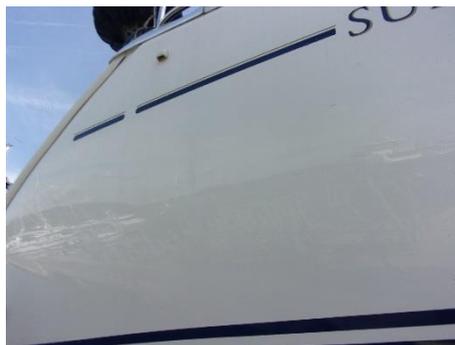
On the portside of the topsides, approximate 10ft forward from the stern, a shallow scuff to the gelcoat was noted. This was found to be a cosmetic issue only.

On the starboard side aft of the vessel, a shallow gelcoat scratch was noted. This was found to be a cosmetic issue only.

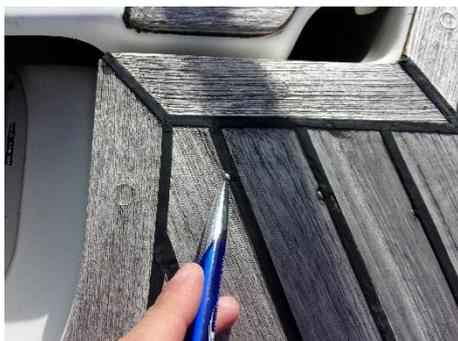
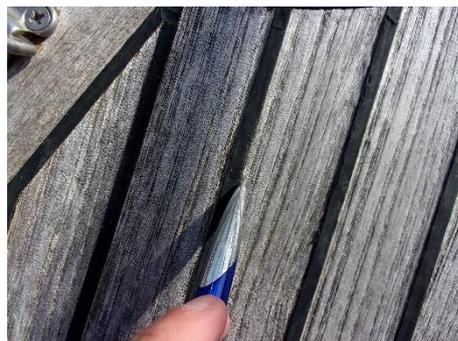
Teak decking: Teak decking was fitted to the vessel from new. This was found to be in a serviceable condition overall. Over the entirety of the teak deck, stainless-steel screws have been screwed into the deck at 45 degree angles, to hold the teak down. Over the whole of the foredeck, as far back as the shroud plates, many of these are now visible. Visible screw heads were also found aft of the shroud plates, but were less frequent in occurrence. Visible screw heads in the teak decking will, over time, cause water ingress into the deck core.

To increase the lifespan of the teak decking, and to prevent moisture ingress into the deck core, I recommend that all of the visible screws in the teak decking are either removed, or screwed further into the deck and teak dowels placed over the top.

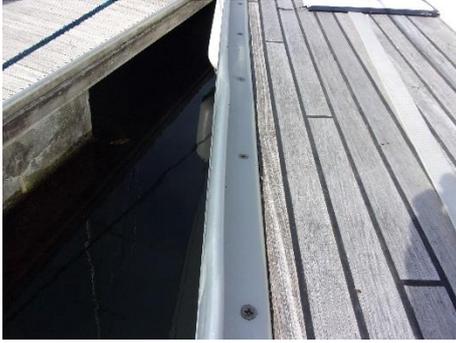
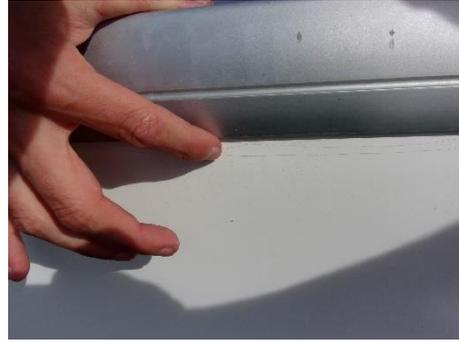
On the starboard side of the vessel, between the 1st and 2nd stanchion bases from the bow, an area of mooring damage to the toerail was noted. Below the bent toerail, minor gelcoat cracking was noted. No evidence of damage to the hull keel join was noted during the survey. Moisture readings surrounding the area of damage were taken and found to be low. The gelcoat cracking and bent toerail were found to be cosmetic issues only.

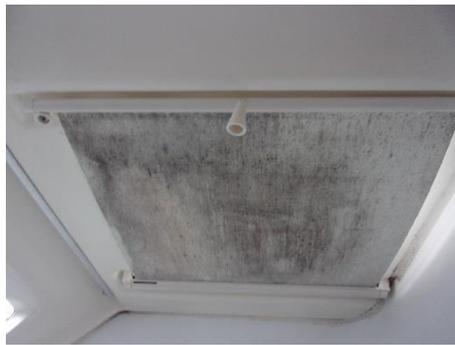
All the hatch blinds were found to be mouldy internally. This is a cosmetic issue only.

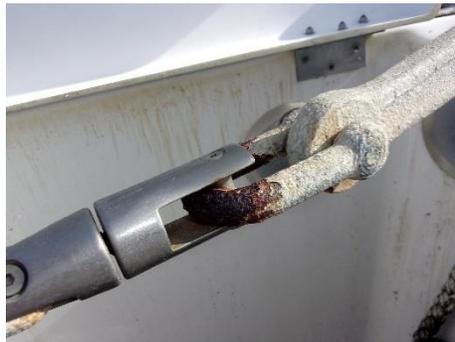
The anchor chain to anchor shackle was found to be beginning to corrode. I recommend that this is replaced within the next two years.

- I recommend that the anchor to anchor chain shackle is replaced within the next two years.

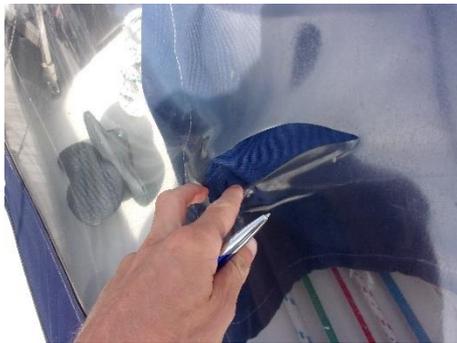
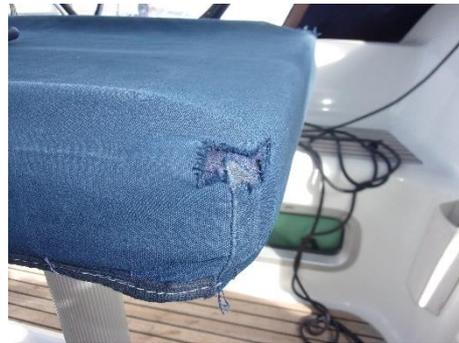
The spray hood was found to be in a fair condition, with the portside forward window being torn. I recommend that a new window is fitted to the spray hood.

The cockpit table cover was found to be torn on every corner.

- I recommend that a new window is fitted to the spray hood.

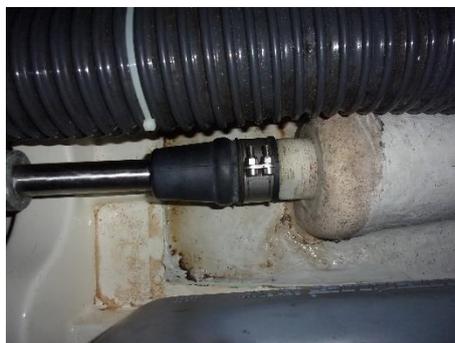
Stern gland: [REDACTED] is fitted with a Volvo Penta dripless shaft seal. This was found to be in a good condition overall, with no evidence of leaking noted during the survey. This type of shaft seal, according to Volvo, should be replaced every 5 years. The seal onboard [REDACTED] is aged 2017. The dripless shaft seal will therefore need to be replaced at the end of the 2022 season.

- I recommend that the Volvo Penta shaft seal is replaced at the end of the 2022 season.

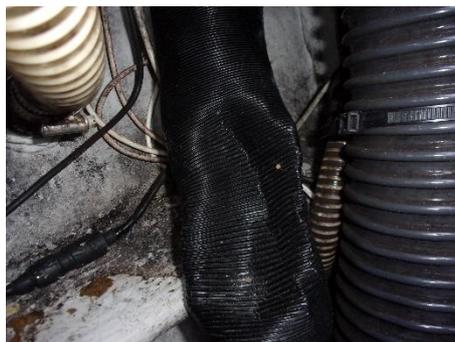
The heater hot air ducting, used to carry hot air from the heater to the interior of the vessel, was found to be crushed in the portside aft cockpit locker. I recommend that the crushed diesel heater hot air ducting is replaced.

- I recommend that the crushed diesel heater hot air ducting is replaced.

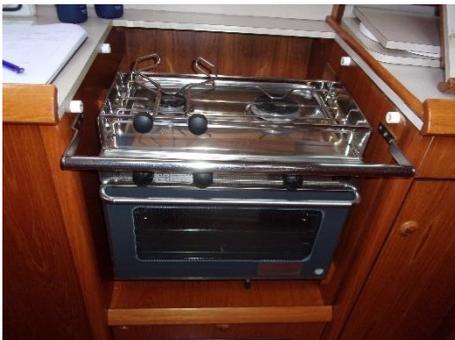
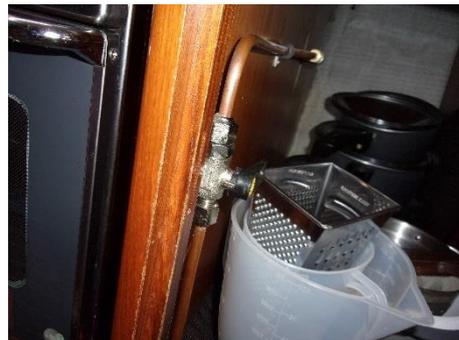
The orange rubber gas piping, connecting the cylinder to the copper gas piping, is dated 2016. This type of piping should be replaced every 5 years. I therefore recommend that the orange gas piping in the gas locker is replaced. The gas regulator was found to be in a good condition.

Once the above gas recommendations have been performed, I recommend that a gas safety inspection is undertaken on the system.

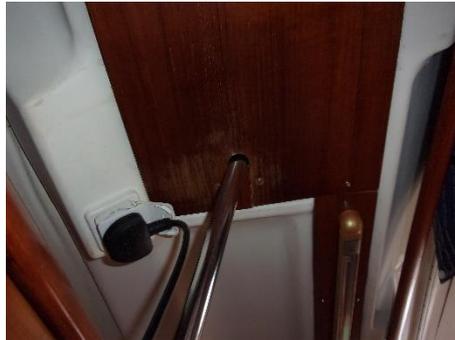
Surrounding the starboard side main shroud chainplate, evidence of minor water ingress internally was noted. I recommend that the area is monitored frequently for any evidence of leaking. If the shroud plate is indeed leaking, I recommend that the shroud plate is re-bed.

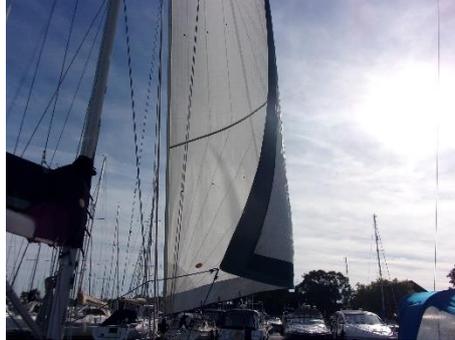
Headsail: The headsail (2007), with blue UV strip, was found to be in a fair condition overall. The sail is structurally sound but is beginning to go baggy with age. The blue UV strip was found to be in a serviceable condition and will most probably need to be replaced in the next two seasons.
