# H T Bettle & Co

Marine Yacht Surveyor

Contessa 32

Type of vessel: Contessa 32 Fin Keel GRP Masthead Sloop.

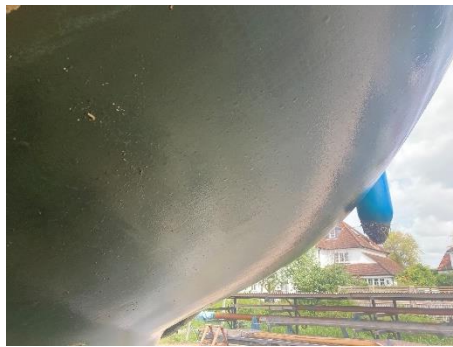
Evidence of osmosis blistering was noted over the entirety of the hull below the waterline. The osmosis blistering was found to range in size, the largest being approximately 1cm in diameter. None of the blistering was found to be delaminating the GRP hull at this time.

Moisture readings: Moisture readings were taken using a Tramex Skipper 5 (scale 3, % MC) randomly over the entirety of the hull below the waterline. The weather conditions on the 19/05/2023 were warm and dry throughout. Readings were found to range from 24 to 30 on the portside, and 23 to 30 on the starboard side (averaging 25.9 on the portside and 27.4 on the starboard side). Readings of 14 and below are considered to be low, readings of 15 to 18 are considered acceptable, and readings of 19 to 30 are considered high. The readings taken on the 19/05/2023 were found to be high.

Due to the osmosis blistering not currently delaminating the GRP matting beneath, I suggest that the osmosis blistering and high moisture readings are not a structural concern at this time.

Skin Fittings: All skin fittings below the waterline were found to be in a good condition externally, with no evidence of galvanic corrosion on the fittings noted at this time.

However, I recommend that it would be wise to monitor the hull below the waterline yearly for the osmosis blistering becoming larger, and beginning to delaminate the GRP beneath. I suggest that the vessel will need an osmosis treatment in the future.

- I recommend that it would be wise to monitor the hull below the waterline yearly for the osmosis blistering becoming larger, and beginning to delaminate the GRP beneath.

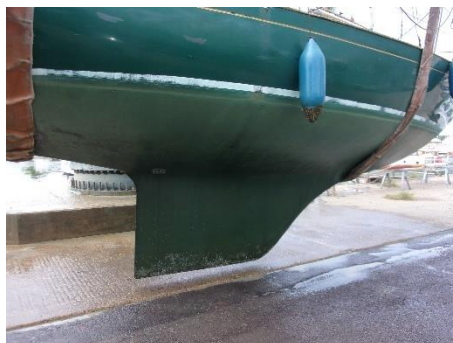
Hull/Keel join: No areas of cracking, or stress related fractures, were noted surrounding the encapsulated keel, both internally and externally.

Keel: The encapsulated keel was found to be in a good condition overall, with no evidence of cracking, expansion, or damage due to grounding noted during the survey.

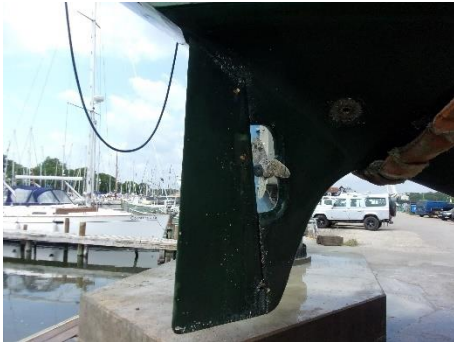
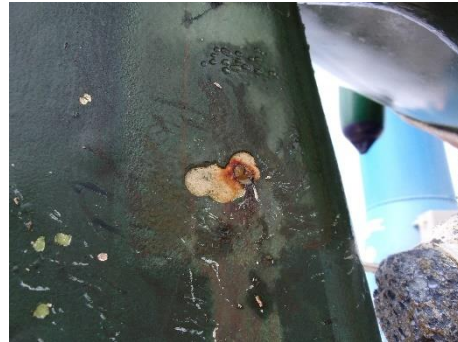
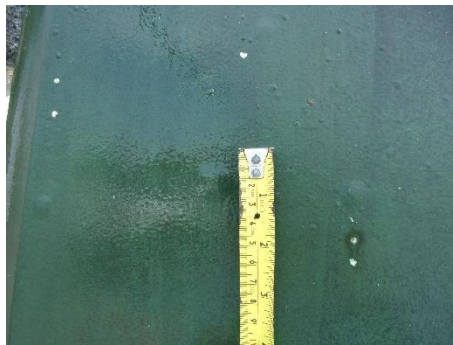
Rudder: The vessel's rudder is of the skeg-hung type and is constructed of GRP. This was found to be in a fair condition overall.

Osmosis blistering was noted over the entirety of the rudder during the survey, the largest of the blistering being approximately 3cm in diameter. Moisture readings of the rudder were taken at random locations and were found to be off the scale over its entirety. Higher readings are common with this age and design of rudder.

On the starboard side of the rudder, rust staining was found to be emitting from the rudder. This is due to the rudder post or steel rudder tangs beginning to corrode.

Due to the extent of the rudder osmosis blistering, combined with the area of corrosion emitting from the rudder, I recommend that an osmosis treatment should be performed on the rudder in the next 5 years. This would involve splitting the rudder to assess the condition of the rudder core, post, and tangs.

- I recommend that an osmosis treatment should be performed on the rudder within the next 5 years.

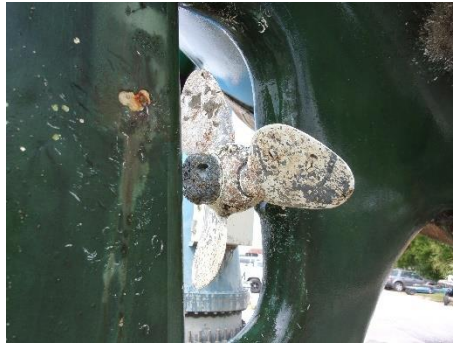
Propeller: The vessel is fitted with a 3-bladed bronze folding Featherstream propeller (2009), attached to a conventional shaft, and running through a cutlass bearing. The propeller was found to be in a good condition overall, with no evidence of damage due to fouling, dezincification, or pitting due to improper cathodic protection. The propeller folding mechanism was found to be in a good condition.

The propeller shaft was found to be in a good condition.

The cutlass bearing was found to be in a good condition, with little to no play noted during the survey.

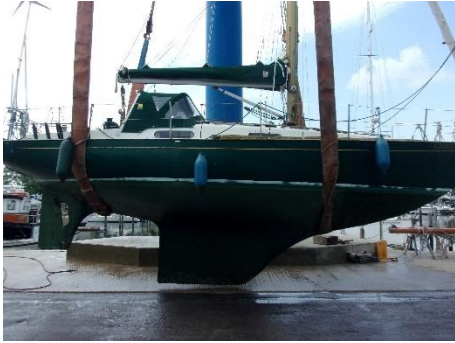
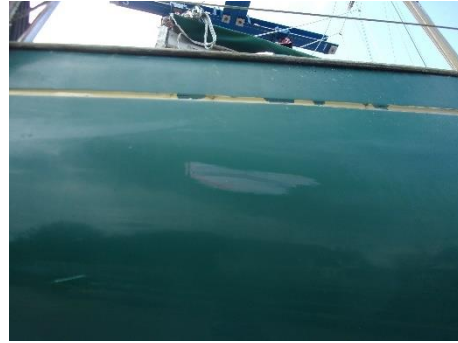
On the starboard side amidships of the vessel, an area of gelcoat scuffing was noted. This was found to be a cosmetic issue only, with low moisture readings.

On the portside amidships of the topsides, a large past gelcoat repair was noted. This was found to be structurally sound, with low moisture readings.

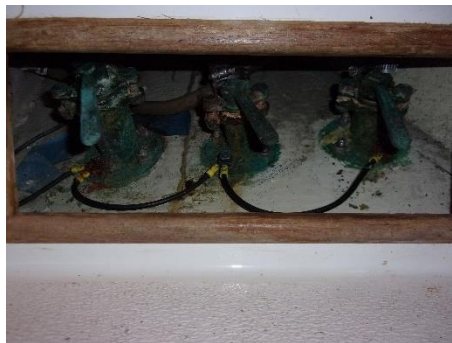
The three Blakes seacocks mounted below the heads were found to be covered with a layer of green powder. This is surface corrosion of the copper alloy. All three seacocks were found to be in a sound condition at this time.

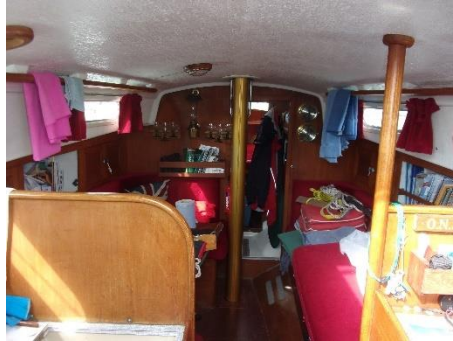
The interior woodwork was found to be in a fair condition overall, beginning to suffer from UV and damp damage in a number of areas. This is a cosmetic issue only at this time.

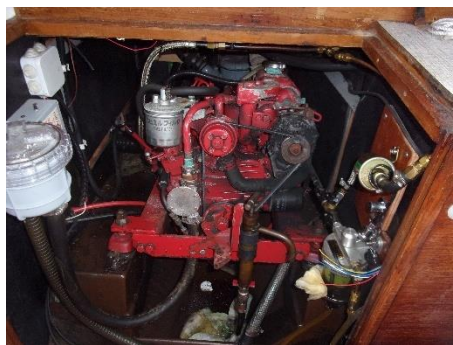
The engine oil was found to be at the correct level and relatively clean. Externally, the engine was found to be in a fair condition, with areas of damaged paint work noted over the engine. Although not a serious issue at this time, I suggest that it would be wise to rust treat and re-paint the engine in the future.

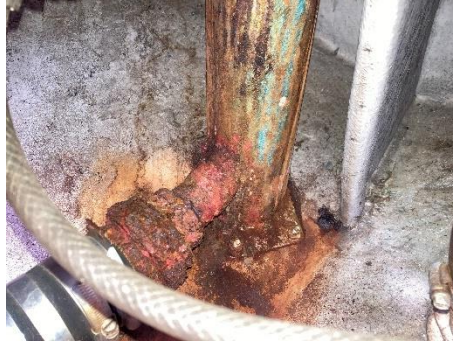
The exhaust rubber piping, elbow and silencer were all found to be in a good condition, with no areas of damage noted. However, the exhaust hull fitting was found to be excessively corroded. I recommend that the exhaust steel hull fitting is replaced.

- I recommend that the engine exhaust steel hull fitting is replaced.

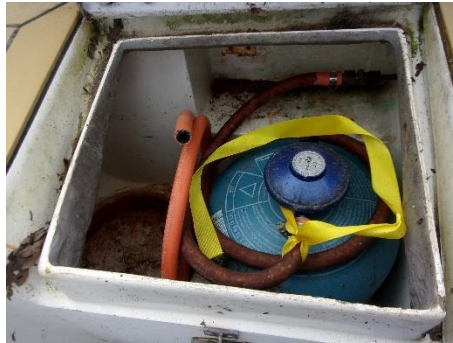
One Campingaz bottle has been fitted within a locker on the portside aft of the cockpit. The gas locker was found to be gas tight. However, the gas locker is drained into the cockpit via a small hole in the base of the locker. This will not allow escaped gas to leave the vessel safely. The gas locker should be drained from the base of the gas locker directly out from the vessel. I recommend that the gas locker is fitted with a proper gas drain, that drains directly out from the vessel.

The gas regulator was found to be out of date and should be replaced.

The orange rubber gas piping (2014) in the gas locker was found to be out of date and should be replaced.

- I recommend that the gas locker is fitted with a proper gas drain, that drains directly out from the vessel.
- I recommend that the orange rubber gas piping in the gas locker is replaced.

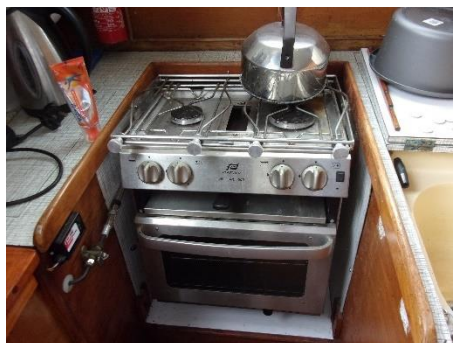
The braided gas hose behind the gas cooker was found to be out of date and should be replaced.

- I recommend that the gas regulator is replaced.
- I recommend that the braided gas hose is replaced.
- I recommend that a gas safety inspection is performed on the gas system, once the above gas recommendations have been undertaken.

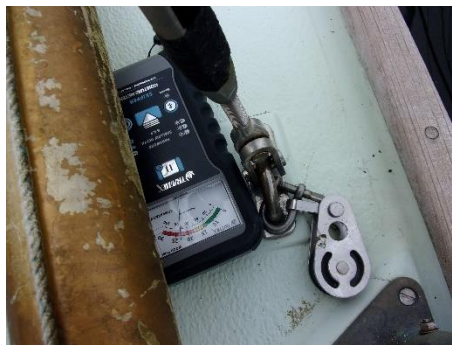
Surrounding the port and starboard side aft lower shroud chainplates, gelcoat cracking was noted. No evidence of the deck raising in these two areas was noted. Moisture readings of the two areas of cracking were taken. The portside was found to have low readings, whereas the starboard side was found to have elevated readings. I therefore recommend that it would be wise to remove the starboard side aft shroud chainplate, repair the gelcoat cracking, and re-bed the fitting using fresh bedding compound.
