H T Bettle & Co

Hustler 30

Type of vessel: Hustler 30 Fin Keel GRP Masthead sloop

Survey was conducted for [REDACTED] for the purpose of insurance
and valuation by Henry Bettle AMSCMS AMRINA AMIMarEST BEng, Marine
Surveyor.

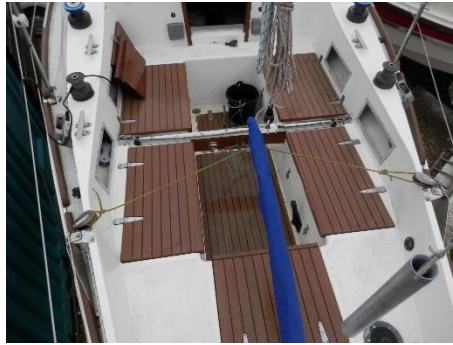
Cockpit:

The vessel benefits from a spacious and safe cockpit. Large cockpit scuppers are fitted for drainage. The vessel has tiller steering. There are five large cockpit lockers located to port, starboard, and aft of the cockpit. These were all found to be in a clean and tidy condition. The gas locker is located in the rear portside locker. The TekDek mounted to the cockpit floor and hatches was found to be in a good condition.

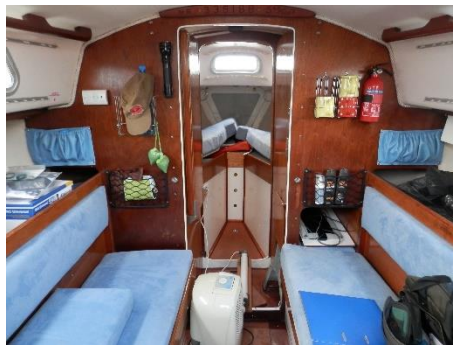
Interior:

The interior is created by a hardwood-faced marine plywood. There is a two-berth forecabin, a separate heads compartment to port amidships, a storage compartment to starboard amidships, and a saloon. The saloon has a settee seat either side, two three single berths, a chart table to port, and a galley to starboard. The joinery below was found to be in good order and the finish too being in a good condition. The floorboards in the saloon were found to be in a good condition. The upholstery and woodwork are in a good condition.
