Beneteau Gran Turismo 38 'Speciale'

Type of vessel: Beneteau Gran Turismo 38 'Speciale'.

Date of Survey: 10/08/2022

Survey was conducted for [REDACTED] for the purpose of Pre-Purchase, Condition, and Valuation by Henry Bettle MCMS AMRINA AMIMarEST BEng, Marine Surveyor.

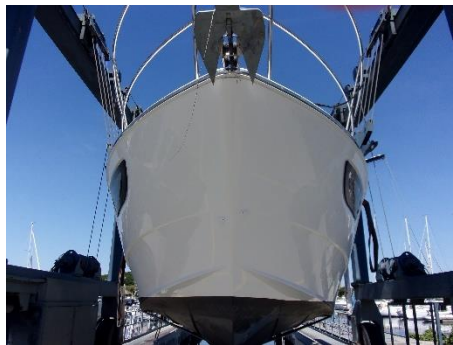
Bow: The bow of [REDACTED] was found to be in a good condition, with no areas of damage noted during the survey.

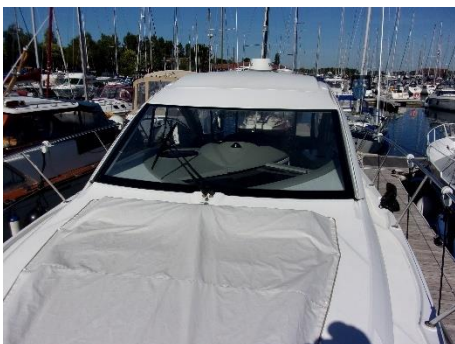
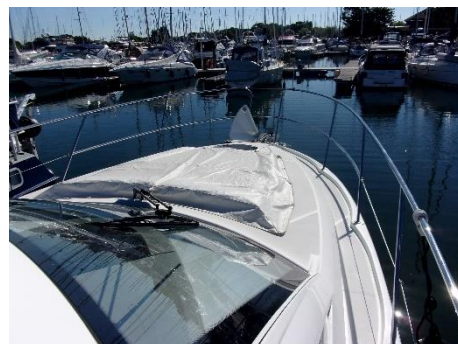
I both walk-tested and percussion-tested the deck and superstructure with a rubber-faced hammer and found no signs of flexing, or degradation of the core. Moisture readings of the deck were taken at 20 random locations and were found to be low over its entirety.

Mooring damage /Abrasion: The deck and superstructure were found to be in a good condition overall, with no evidence of any structural or major cosmetic issues noted during the survey.

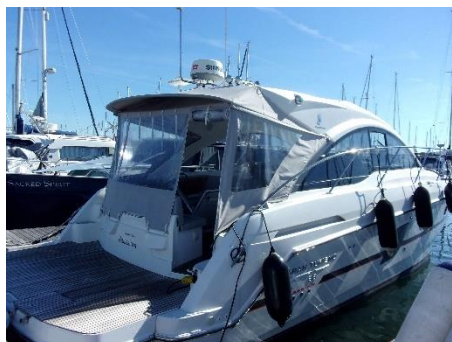
The vessel is fitted with a cockpit cover. The cover was found to be in a good condition overall, with no evidence of tearing, or damage due to UV, noted during the survey.

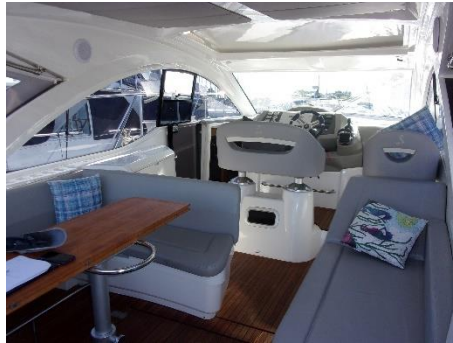
The cockpit gelcoat was found to be in a good condition, with no areas of major cosmetic damage noted during the survey

The cockpit upholstery was found to be in a good condition overall, with no areas of major cosmetic damage noted.

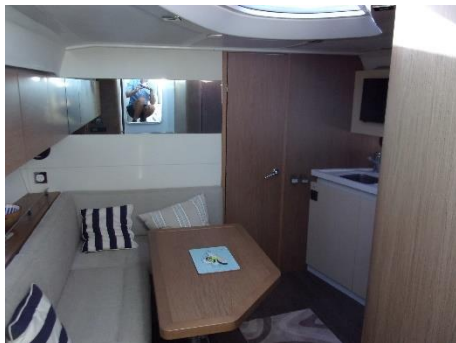
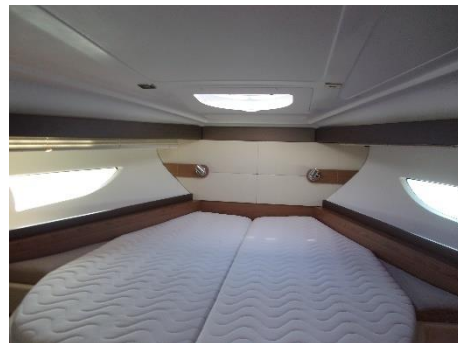
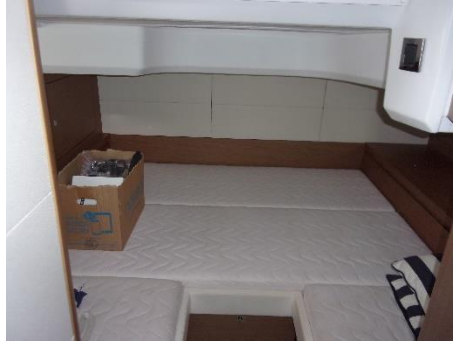
The interior is created by a white gelcoat-faced GRP moulding, as well as hardwood and hardwood-faced plywood. The interior was found to be in a very good condition overall.

The cream upholstery was found to be in a good condition overall, with no areas of major damage noted during the survey

The v-berth mattresses were found to be in a good condition overall. The portside mattress was found to be marked on the top. This is a cosmetic issue only.

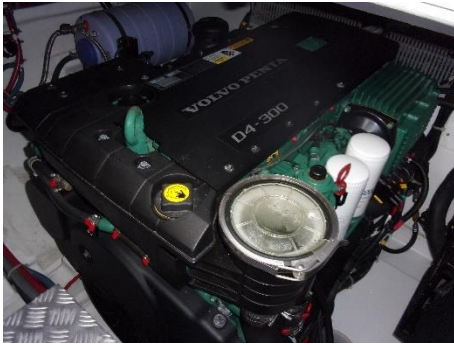
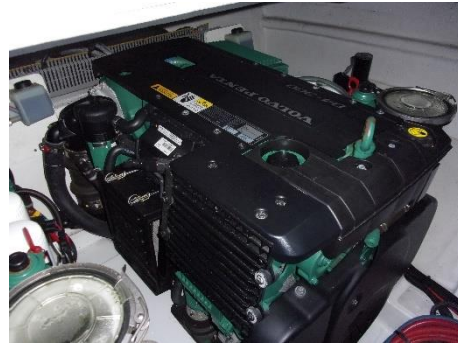
Twin Diesel D4 300 HP Volvo Penta duo-prop diesel inboard engines have been fitted to [REDACTED]. The engines are original to the motor yacht. The hours of the engines are 358 (P), and 358(S). The engine serial numbers are A341862 (P) and A341864(S). Both engines were last professionally serviced in 04/2022.

Both engines were started during the survey, warmed up to temperature, and tested under load. Both engines started with ease and ran well throughout.

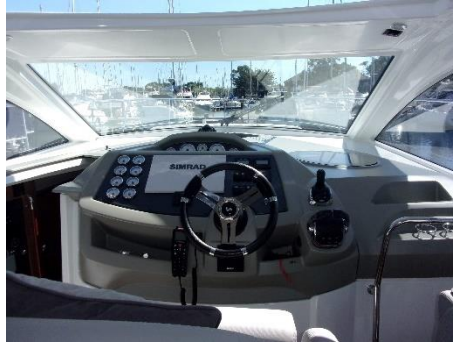
The exhaust system was found to be in a good condition, where access was possible.

Engine controls: The throttle and engine dials were all found to be in a good condition when tested. The Volvo joystick control could not be tested during the survey as the vessel was moored up for the inspection.

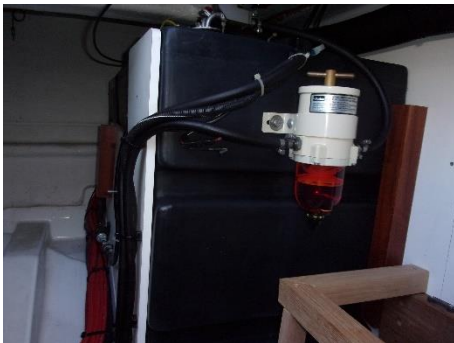
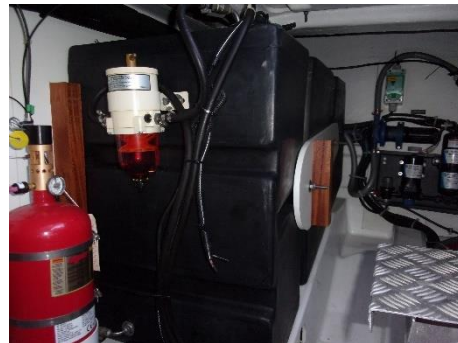
There are two 325 litre plastic fuel tanks fitted onboard, either side of the engine bay, forward of the engines. The tanks, where visible, were both found to be in a good condition, with no evidence of damage or leaking noted during the survey. Both tanks are correctly fastened to the vessel with metal clamps. There was no smell or sign of fuel noted surrounding the tanks or in the bilges in the engine bay.

The rubber piping was all found to be in a good condition, the correct ISO standard, and secured properly to the boat. The fuel filters were both found to be in a good condition. No evidence of any diesel bug or water contamination in either of the fuel filters was noted. All metal fittings have been earthed correctly.

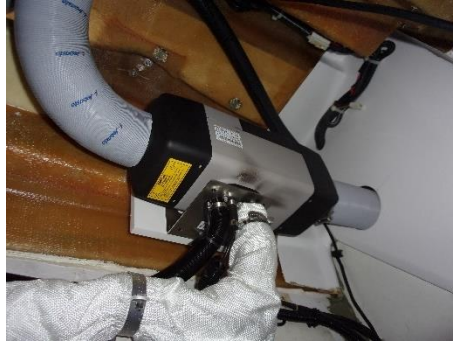
Heating: A Webasto heater has been mounted to the vessel on the portside of the engine bay. The heater, piping, fuel line, and exhaust were all found to be in a good condition. The heater was tested during the survey and was found to be working correctly. The heater control is mounted at the saloon control panel.

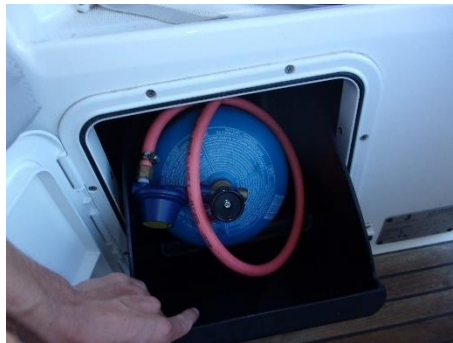
The gas regulator was found to be in a good condition.

The copper gas piping, where visible, was found to be in a good condition, with no areas of damage noted.

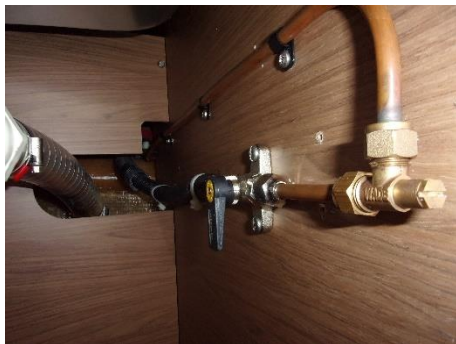
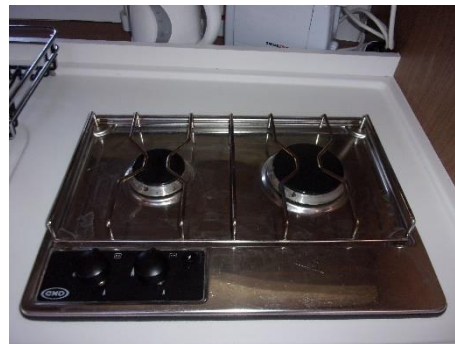
The gas shut off valve, located below the galley sink, was found to be in a good condition and working correctly.

The Eno gas hob was found to be in a good condition, with no areas of damage noted. The hob was tested during the survey and was found to be working correctly.

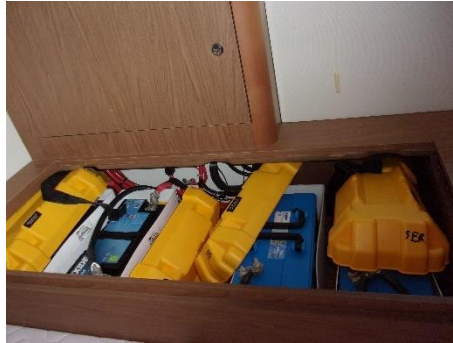
The vessel has four batteries fitted onboard. Two 115Ah batteries and two 95Ah batteries are located on the portside of the aft cabin. The batteries are all correctly housed and well vented.

All batteries were checked using a voltmeter and were found to be in a good condition, producing good output voltages and at 100% health (13.71V, 13.71V, 13.60V, 13.56V).

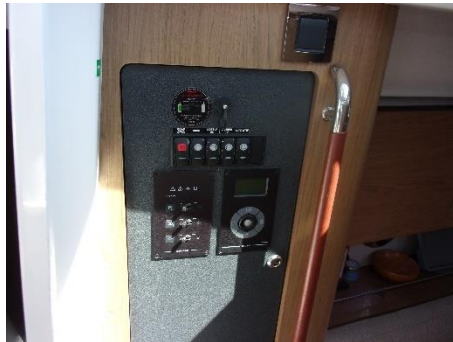
Four isolator switches are located on the saloon control panel. All isolator switches were found to be working correctly during the survey.

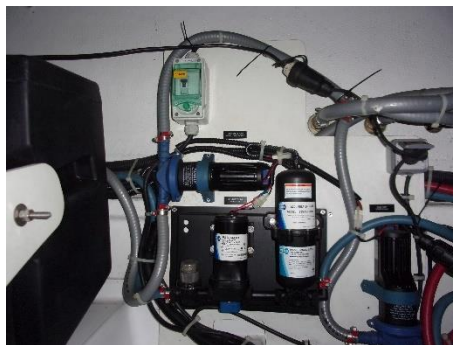
The pressurised water pump and accumulator tank, located on the starboard side of the engine bay, were found to be in a good condition.

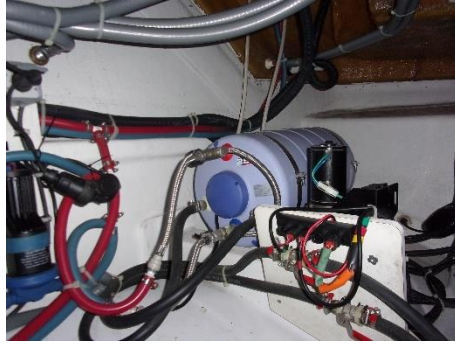
Hot water: The calorifier, with immersion heater, is located on the starboard side of the engine bay. The calorifier was found to be in a good condition, with no areas of damage or corrosion noted. All the hot water pipe work was found to be in a good condition where visible.

The hot water system was tested during the survey and was found to be working correctly.

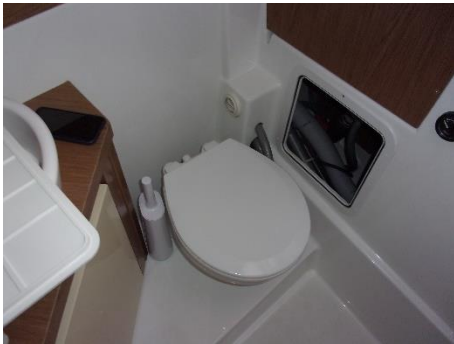
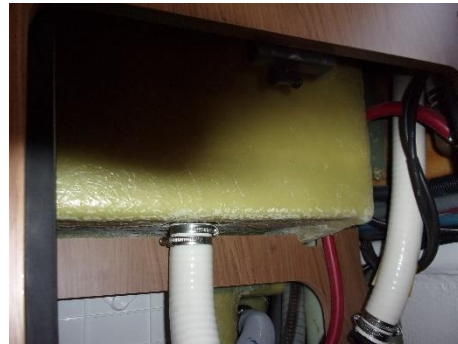
There is a Jabsco electric toilet system fitted to this motor yacht. The toilet was found to be in a good condition when tested. The pipework was found to be in a good condition and is the proper sanitary grade piping. The toilet pumps (inlet and outlet) were found to be working correctly during the survey.

There is an 80-litre GRP holding tank located directly aft of the heads. The holding tank was found to be in a good condition, with no signs of any damage noted. The tank is gravity drained. The holding tank was found to be full during the survey.
