Marine Yacht Surveyor

Moody 346

Type of vessel: Moody 346 Fin Keel GRP sloop

Survey was conducted for [REDACTED] for the purpose of pre-purchase, condition and valuation by Henry Bettle AMSCMS AMRINA AMIMarEST BEng, Marine Surveyor.

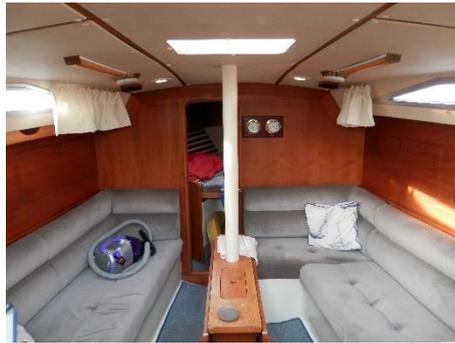
The joinery below was found to be in good order and the finish too being in a good condition.

The upholstery is in a good condition overall. The connecting Velcro was coming away from the starboard side saloon cushions. This should be reattached.

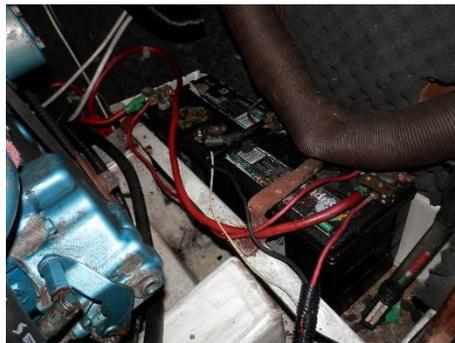
The vessel has two batteries fitted onboard (both 86 AH). Both batteries are located in front of the engine. The batteries look to be in a good condition, with no signs of any leaking. Both batteries are housed and vented correctly. The wiring surrounding them is in a serviceable condition.

A voltmeter was used to check the output of each battery, which found that all batteries were producing a good voltage.

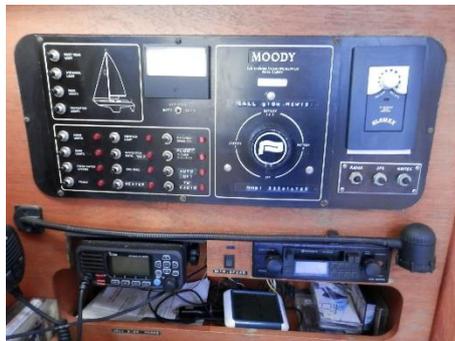
A switch board is located above the chart table.

During the survey, every item on the switch board was tested. There were no issues with the switchboard, and most items worked as they should.

The stern navigation light was not working during the survey. This should be serviced or replaced. The masthead navigation light could not be seen working during the survey due to the bright conditions.

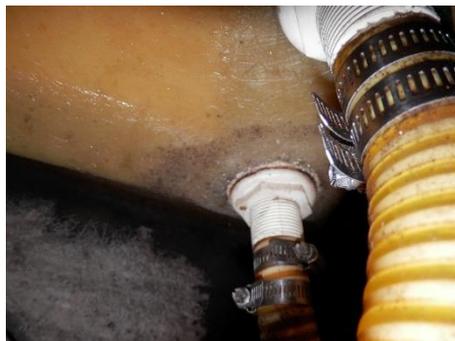
Two fibreglass water tanks are fitted to [REDACTED]. The tanks are located under each of the saloon seats. The tanks externally were found to be in a good condition, with no signs of water leaking from the tanks into the bilges. The internal condition of the tanks could not be checked.

The piping coming out of the tanks looks to be in a good condition and is well secured throughout the vessel.

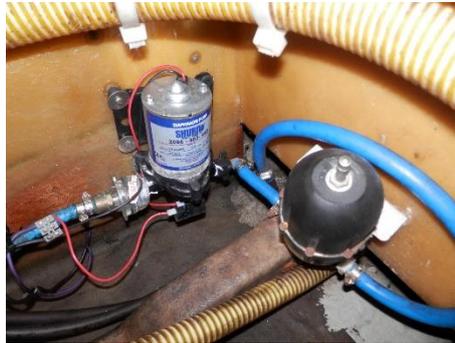
The water pump is located under the starboard saloon seat. This is in a good condition and is activated correctly using the taps and control panel switch. The shower drain pump was activated correctly using the switch mounted in the heads.

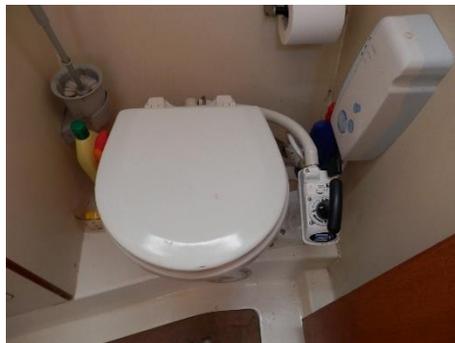
There is a Jabsco manual toilet system fitted to this yacht. The toilet was found to be in a good condition when tested, with no signs of leaking. The manual pump was found to be in a good condition, with no areas of leaking noted.

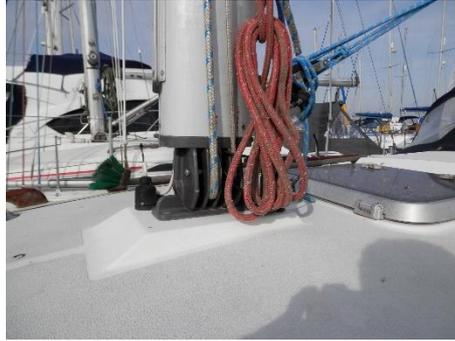
The mast is stepped by a cast aluminium deck plate and supported internally by a metal kingpost that runs down to the bilge. The mast step was found to be in a good condition, with no signs of cracking, distortion or stress related marks. No compression of the deck was noted. The kingpost and its bilge mounting were found to be in a good condition.
