Jeanneau NC9

Type of vessel: Jeanneau NC9.

Vessel Lying: Swanwick Marina, Hamble.

Survey was conducted for Mr Ed Davies for the purpose of pre-purchase, condition and valuation by Henry Bettle AMSCMS AMRINA AMIMarEST BEng, Marine Surveyor.

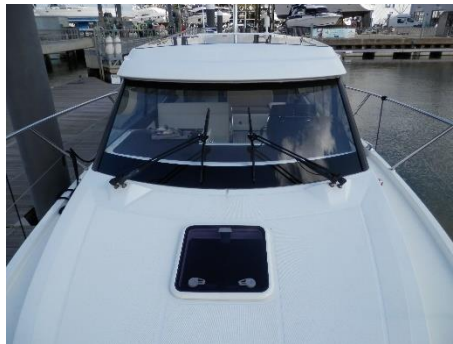
I both walk-tested and percussion-tested the deck and superstructure with a rubber-faced hammer and found no signs of flexing, or degradation of the core. Moisture readings of the deck were taken at 20 random locations and were all found to be good.

The deck and superstructure were found to be in a good condition, with no evidence of any structural issues noted.

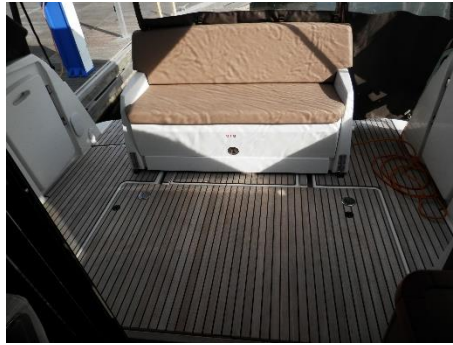
There is a small gelcoat chip aft of the engine bay hatch, in the middle of the cockpit. This should be filled with a gelcoat filler.

There is an area of gelcoat cracking around the portside aft corner of the cockpit. This is a cosmetic issue only.

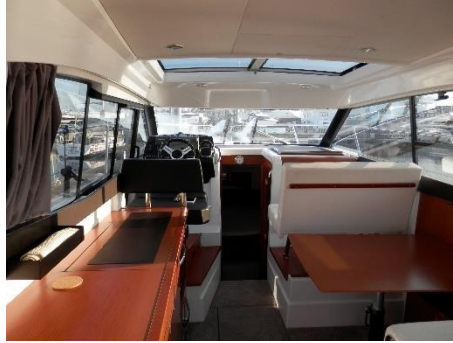
The upholstery is in a good condition overall, with one very small area of marking on the aft saloon seat cushion. The V-berth and amidships berth mattresses were found to be in a good condition.

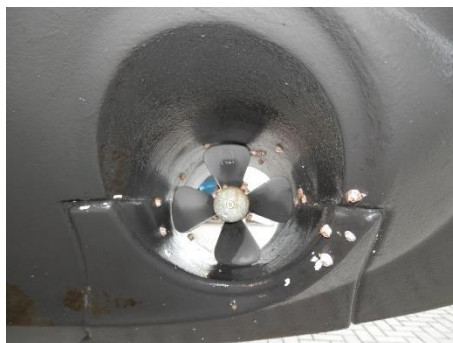
Bow thruster: The bow thruster was tested during the survey and worked correctly. Internally and externally, the thruster was found to be in a good condition, with no areas of damage or corrosion noted.

- Replace the engine oil for the next season.

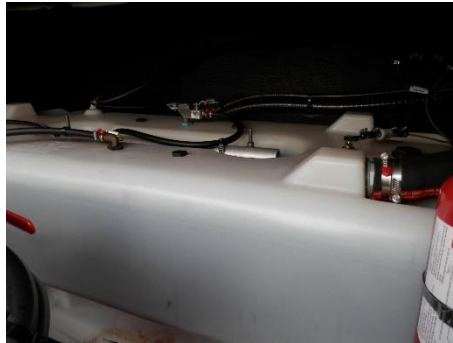
There is one 300 litre plastic fuel tank fitted under the cockpit floor. The tank was found to be in a good condition, with no areas of damage noted. The tank is correctly fastened to the vessel. There was no smell or sign of fuel noted around the tank or in the bilges.

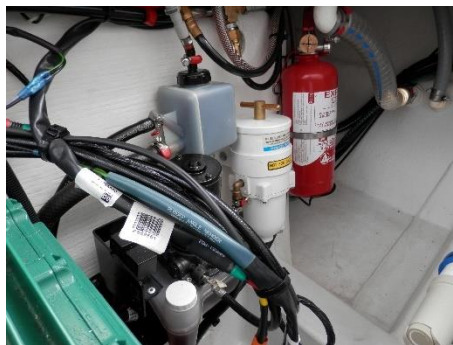
The rubber piping and tank valves were found to be in a good condition and secured properly to the boat. The fuel filter is in a good condition. All metal fittings have been earthed correctly. The emergency fuel shut off valve was found to be working correctly.

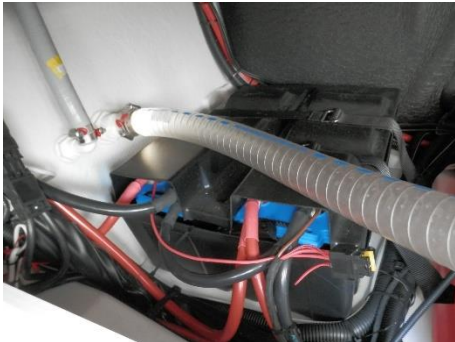
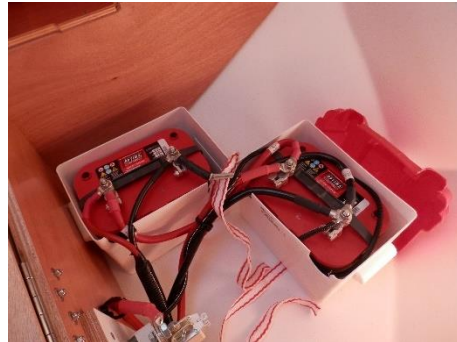
The other two batteries are located under the V-berth bed (50AH AGM). These again are mounted properly in battery boxes and are correctly vented.

All batteries were checked using a voltmeter and found to be in a good condition.

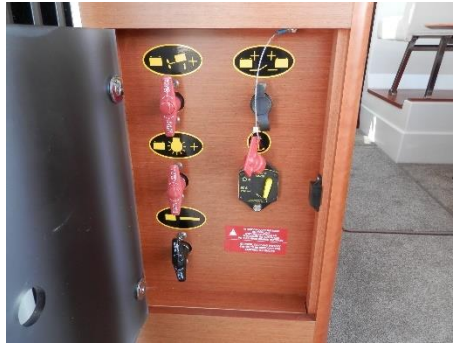
There are three isolator switches located at the aft of the galley. These were all found to be working correctly. The wiring behind the switches is tidy and clean.

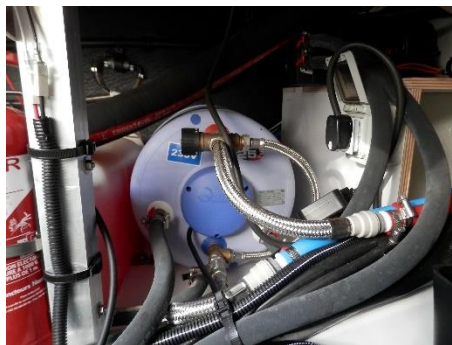
Hot water: The hot water system was tested during the survey and found to be working correctly. The calorifier and piping are all in a good condition externally.

- Check whether the water tank gauge is working by filling the tank.

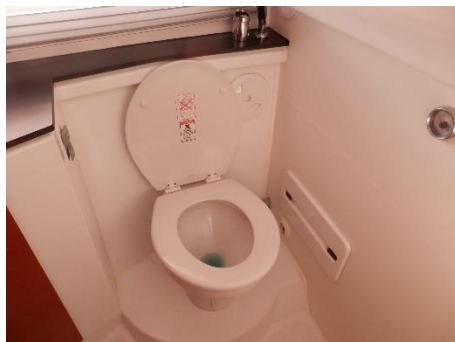
There is a Jabsco electric toilet system fitted to this motor yacht. The toilet was found to be in a good condition when tested. The pipework is in a good condition and is the proper sanitary grade piping. The electric pump was found to be working correctly during the survey.
