Jeanneau Sun Odyssey 40

Type of vessel: Jeanneau Sun Odyssey 40 Fin Keel GRP sloop

Date of Survey: 20/09/2022

Survey was conducted for [REDACTED] for the purpose of Pre-Purchase, Condition and Valuation by Henry Bettle MCMS AMRINA AMIMarEST BEng, Marine Surveyor.

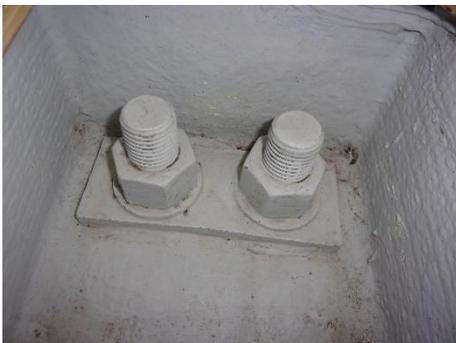
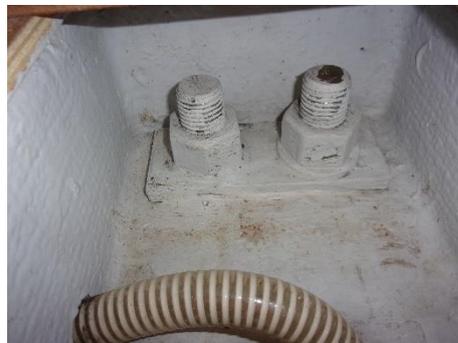
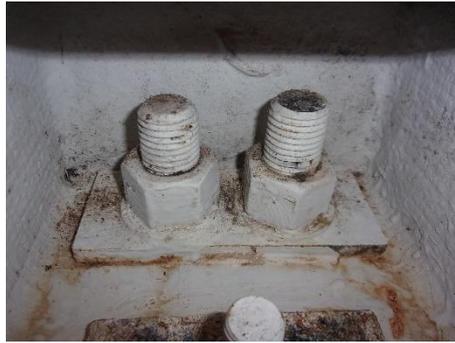
The portside forward keel bolt, as well as the two aft keel bolts, were found to be beginning to corrode. This is a minor issue only at this time. However, I recommend that it would be wise to rust treat and protect the portside forward and two aft keel bolts in the future.

All other keel bolts were found to be in a good condition.

Due to the vessel being over 10 years old, a maintenance program of removing a different set of keel bolts for inspection every few years is to be recommended.

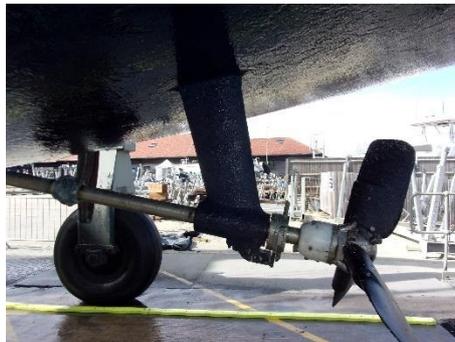
The cutlass bearing was found to be in a good condition, with minimal to no play noted during the survey.

The "P" bracket was found to be in a good condition, with no evidence of movement or corrosion noted.

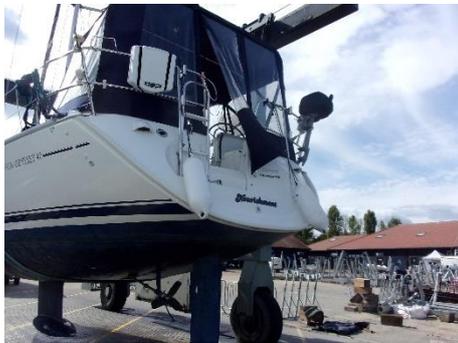
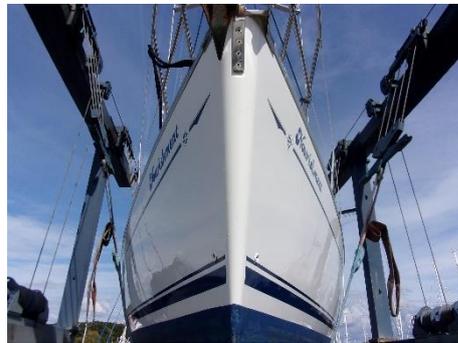
Transom: The transom of the vessel was found to be in a good condition overall, with no evidence of structural or major cosmetic damage noted during the survey.

Bow: The bow of [REDACTED] was found to be in a good condition overall, with no areas of structural or major cosmetic damage noted during the survey.

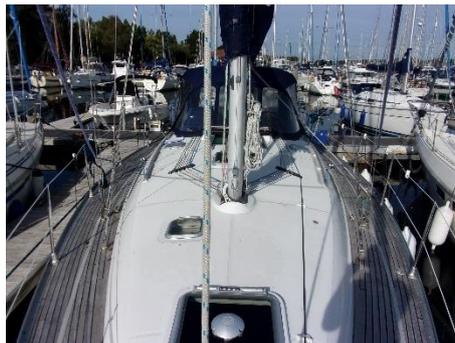
I both walk-tested and percussion-tested the deck and coachroof with a rubber-faced hammer and found no signs of flexing, or degradation of the core. Moisture readings of the coachroof were taken and were found to be low to acceptable over its entirety.

Damage: No areas of structural or major cosmetic damage was noted to the deck or coachroof of the vessel.

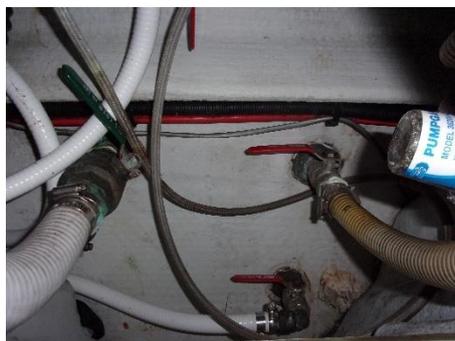
All seacocks were found to be in a good condition and moving freely during the survey.

Stiffeners Attached: The stiffeners strengthening the keel mounting, coated in GRP, were all found to be in a good condition.

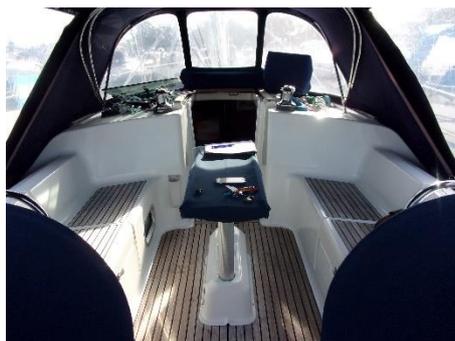
The cockpit teak decking and gelcoat was all found to be in a good condition, with no evidence of structural or major cosmetic damage noted.

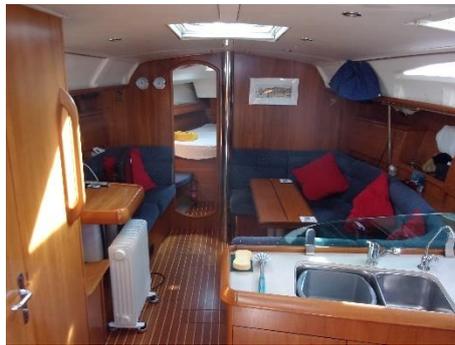
The joinery below was found to be in good order and the finish too being in a good condition overall.

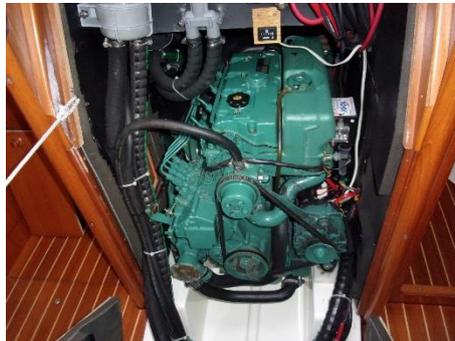
The exhaust was found to be in a good condition, with no evidence of leaking or damage noted.

The gearbox was found to be in a good condition, going in and out of gear with ease.

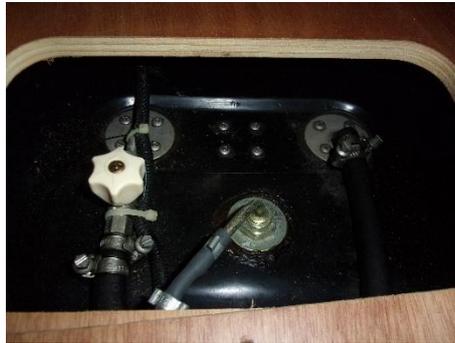
There is an 136L plastic fuel tank fitted below the aft berth of the vessel. The tank is held in place by metal clamps. The tank was only partially visible for the inspection.

All piping and valves were found to be in a good condition and secured properly to the boat. The fuel filter, mounted to aft of the engine, was found to be in a good condition. The fuel gauge, mounted at the engine control panel, was found to be working correctly. The fuel gauge was reading as 3/4 full.

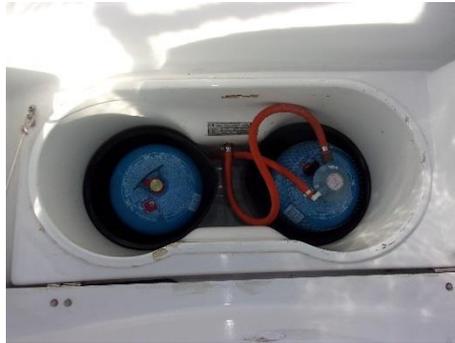
The gas system has a single gas Campingaz bottle (with spare) located in the starboard side aft cockpit locker. The gas locker is well vented and self-draining.

The orange rubber gas piping, connecting the cylinder to the copper gas piping, is dated 2016. This type of piping should be replaced every 5 years. I therefore recommend that the orange gas piping in the gas locker is replaced. The gas regulator was found to be in a good condition.

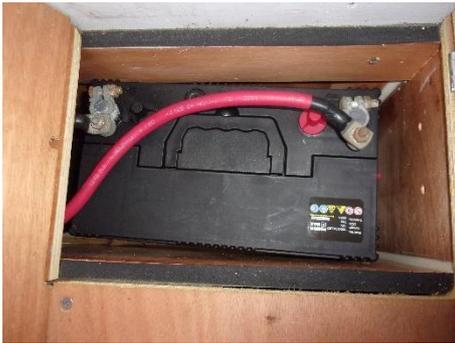
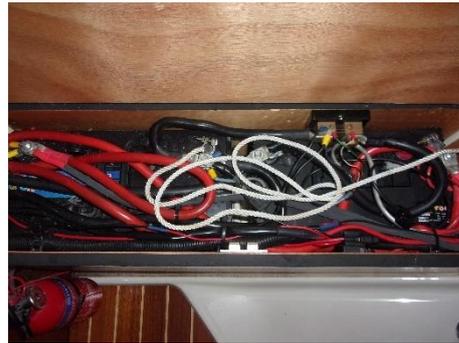
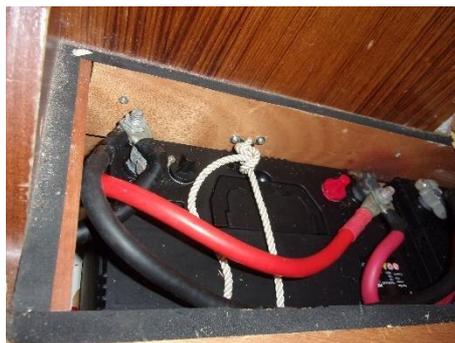
One 84Ah battery is located below the starboard side cockpit locker. The battery was found to be in a good condition and housed and vented correctly.

A voltmeter was used to check the output of each battery, which found that all batteries were producing a good output voltage and were at 100% health.

The four batteries below the aft berth and cockpit locker are connected to three isolator switches. The isolator switches are located to aft of the engine bay and were found to be working correctly.

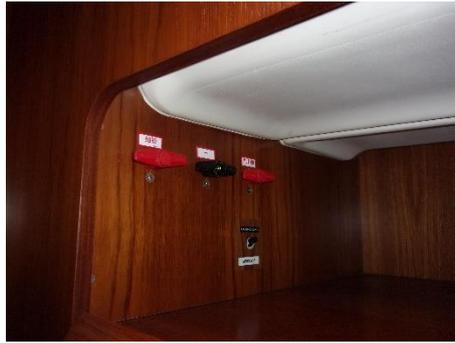
The bow battery is connected to one isolator switch located within the v-berth cabin. This was found to be working correctly.

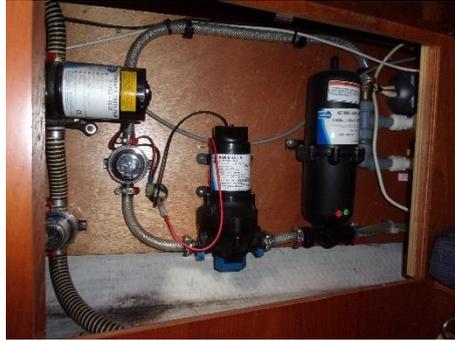
The pressurised water pump and accumulator are located below the chart table. Both were found to be in a good condition. The water pump is activated correctly using the taps and control panel switch.

All taps were tested during the survey and were found to be working correctly.

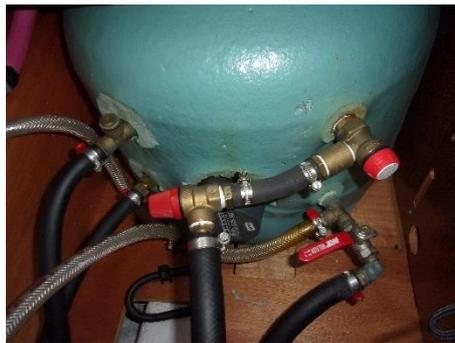
Hot water: A calorifier is fitted below the starboard side aft saloon seat. This was found to be in a good condition where visible, being heated correctly using the engine and 240V immersion heater. The hot water system was tested during the survey and was found to be working correctly.

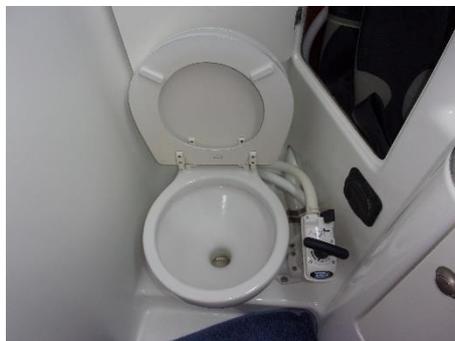
A Jabsco manual toilet system has been fitted to this yacht. The toilet was found to be in a good condition, with no evidence of leaking noted. The seals on the toilet manual pump were found to be in a good condition.

The toilet pipework was all found to be in a good condition and is the correct sanitary grade, rising correctly above the heeled waterline.

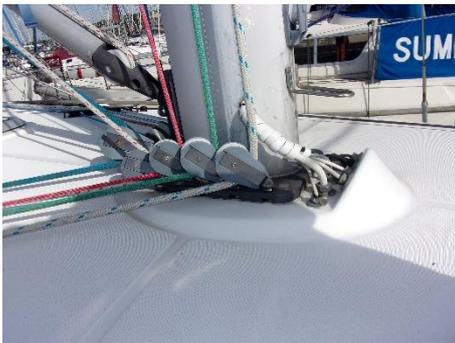
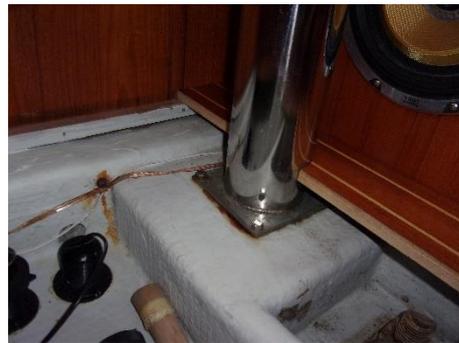
The mast is stepped by a cast aluminium deck plate and supported internally by a metal kingpost that runs down to the bilge and by the plywood main bulkhead. The mast step was found to be in a good condition, with no evidence of cracking, distortion, or stress related marks. The lower kingpost mounting was found to be in a good condition, with no signs of stress related damage.

Moisture readings of the area of coachroof surrounding the mast step were taken and found to be low.

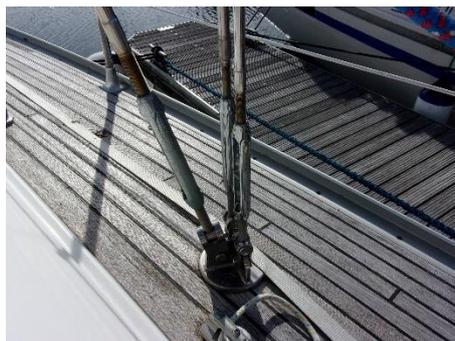
Bottle screws are fitted at the base of each shroud, all of which are correctly secured with split pins.

The boom was found to be in a good condition.

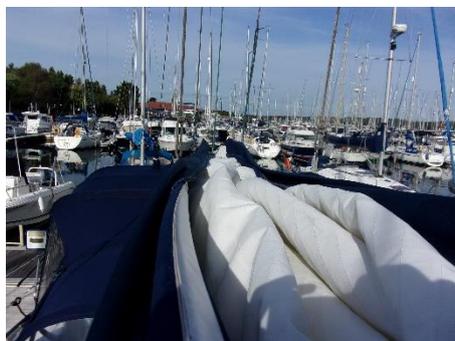
Mainsail: The mainsail could not be raised due to the wind direction during the survey. The sail could therefore only be examined within the sail bag. The mainsail (age 2007) was found to be in a good condition, where visible. No evidence of damage to the sail was noted during the survey.

Headsail: The headsail (2007), with blue UV strip, was found to be in a fair condition overall. The sail is structurally sound but is beginning to go baggy with age. The blue UV strip was found to be in a serviceable condition and will most probably need to be replaced in the next two seasons.
