# H T Bettle & Co

Marine Yacht Surveyor

Contessa 32

Type of vessel: Contessa 32 Fin Keel GRP Masthead Sloop.

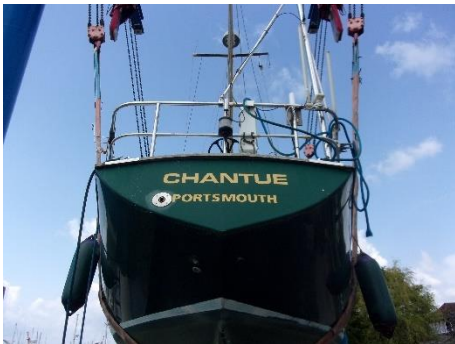
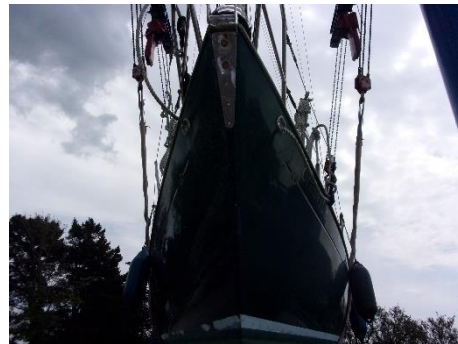
Transom: The transom of the vessel was found to be in a good condition, with no evidence of structural or major cosmetic damage noted during the survey.

Bow: The bow of [REDACTED] was found to be in a good condition, with no areas of structural or major cosmetic damage noted.

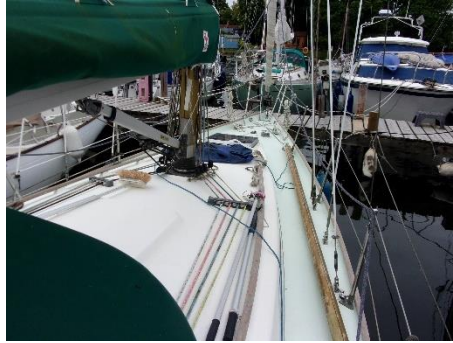
The deck and coachroof of the vessel still have their original light blue gelcoat, with the sides of the coachroof being a white gelcoat, and moulded in non-slip areas. The gelcoat was found to be in a good condition, with no areas of crazing or pinhead blistering noted during the survey.

Damage: No areas of structural, or major cosmetic damage to the deck or coachroof of the vessel was noted during the survey.

I both walk-tested and percussion-tested the superstructure of the vessel. No areas of the deck or coachroof delaminating were noted during the survey.

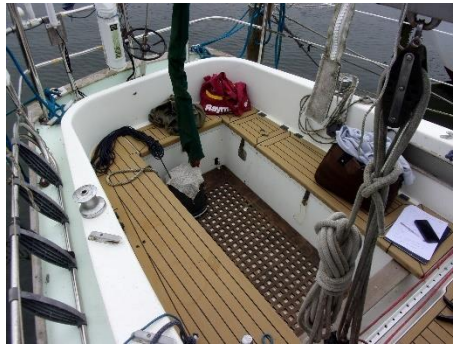
The cockpit woodwork and teak affect decking was found to be in a good condition overall, with no areas of major damage noted. The cockpit gelcoat was found to be in a good condition overall, with no areas of structural or major cosmetic damage noted.

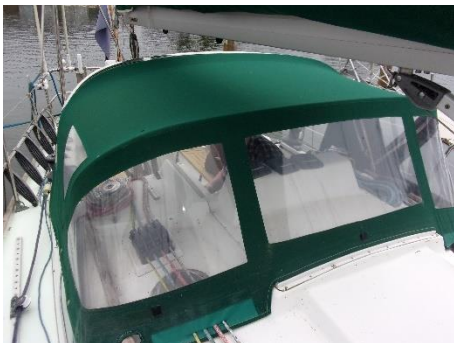
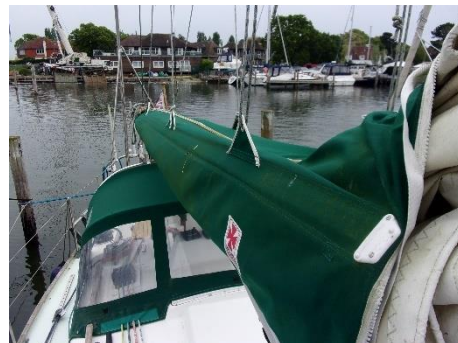
Both the spray hood and the stack pack were found to be in a good condition, with no evidence of damage noted during the survey.

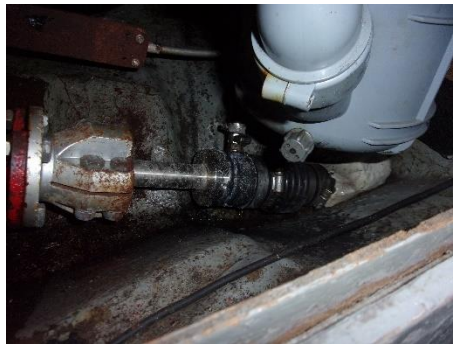
Stern gland: A PSS dripless shaft seal has been fitted to [REDACTED] approximately 8 years ago. This was found to be in a good condition, with no evidence of leaking or damage noted during the survey.

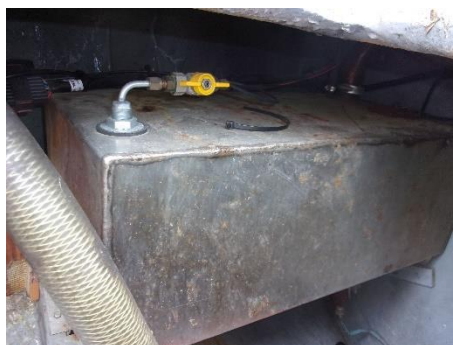
There is a 32L stainless-steel fuel tank fitted within the portside cockpit locker. The tank is secured in place with metal clamps.

The fuel tank was found to be in a good condition, where visible, with no areas of damage noted.

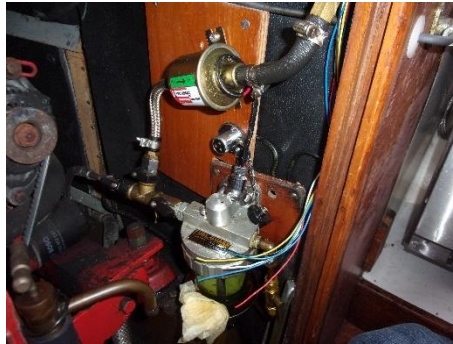
The fuel filter, located to the portside of the engine, was found to be in a good condition. No evidence of diesel bug was noted in the fuel system.

The fuel shut off valve, located above the fuel tank, was found to be in a good condition.

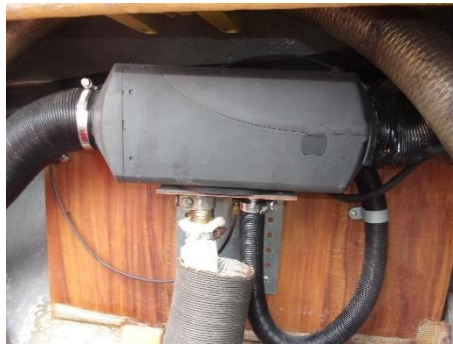
Heating: An Eberspacher diesel heater has been fitted within the portside cockpit locker of the vessel. The heater, fuel line, exhaust hose, and hot air ducting, were all found to be in a good condition.

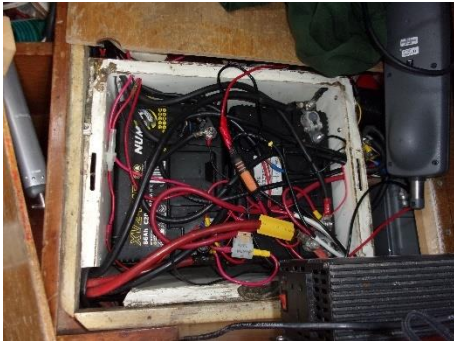
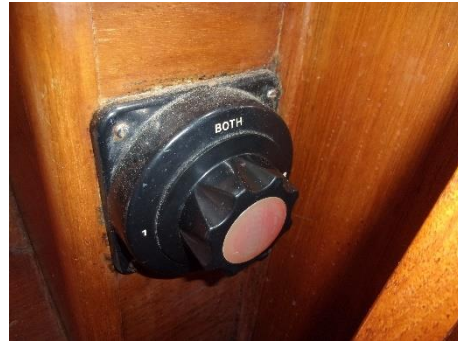
The three batteries are connected to one large isolator switch, located beneath the chart table. The isolator switch was tested during the survey and was found to be working correctly.

A switch board is located at the chart table of the vessel.

During the survey, every item on the switch board was tested. There were no issues with the switchboard, and all items worked as they should.

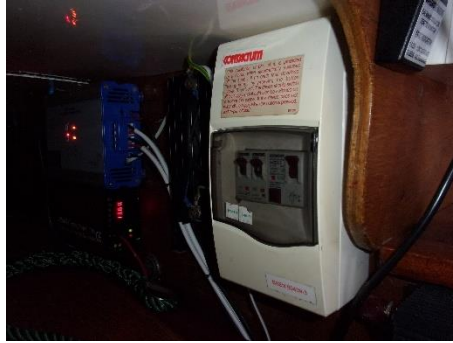
Shore power: The shore power system, including an RCD breaker box within the quarter berth, a galvanic isolator at the chart table, and a battery charger housed within the quarter berth, was found to be in a good condition, operating correctly during the survey.

The wind generator and control were both found to be in a good condition, operating correctly during the survey.

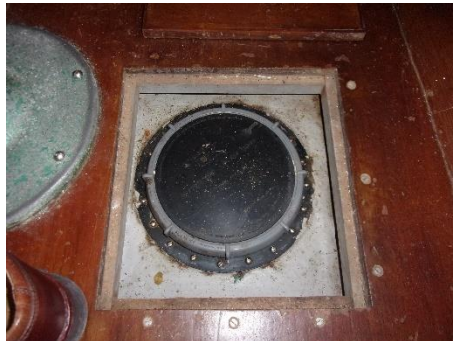
One water tank has been fitted to [REDACTED]. One keel tank is located below the saloon soleboards. The tank is difficult to inspect, with only a small section of the tank clearly visible for inspection. The tank, where visible, was found to be in a good condition, with no signs of water leaking from the tank into the bilges. The internal condition of the tank was found to be in a good condition.

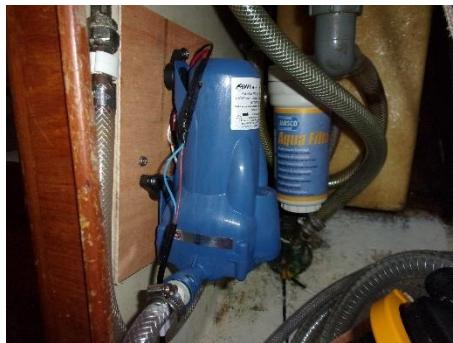
A pressurised water pump is located below the galley sink. This was found to be in a good condition, operating correctly during the survey.

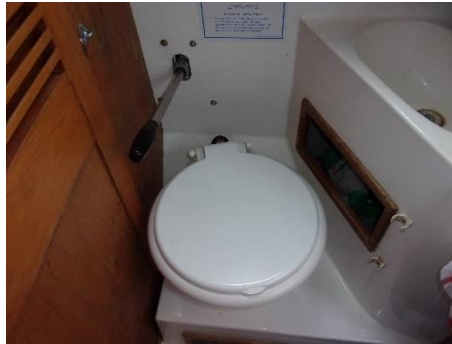
The toilet pipework was found to be in a good condition and including vented loops that rise at least 20cm above the healed waterline.

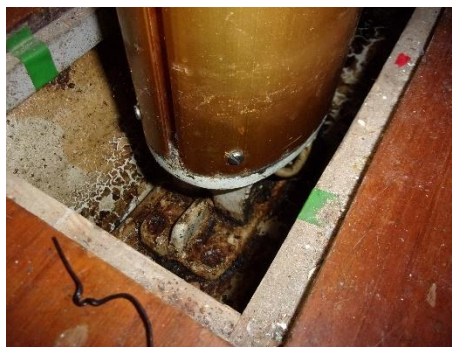
The mast is bilge stepped by a cast aluminium plate. The mast step was found to be in a good condition, with no evidence of cracking, distortion, or stress related marks.
